From Infrastructure to Icon: a Historical and Archaeological Analysis of the Randell Dry Dock.

Britt Burton¹

Abstract

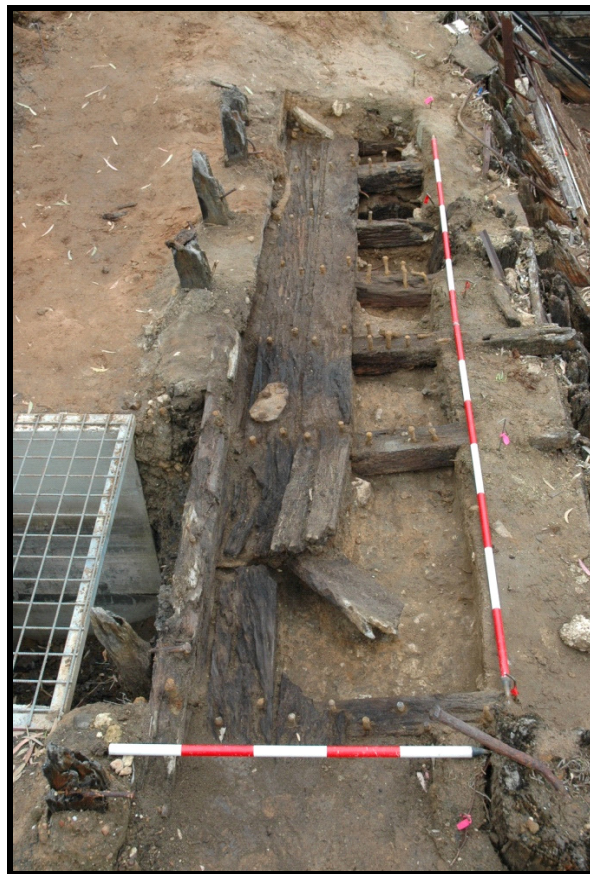
Figure 2. Looking east along the uncovered walkway in Trench 1. (Photograph by B. Burton, 2009).

berth alongside (Maritime Museum, Port Chalmers, 24 September 2010). The results of Trench 1 suggest that the walkway appears similar in design to that attached to Alpha in New Zealand. Randell's dock has three layers of planking attached to 0.67 metre vertical support beams. However, unlike Alpha, there are no diagonal support beams underneath the walkway to ensure its stability. A more likely scenario is that the walkway was constructed at Mannum. An attached walkway was a possibility for a floating dock and could have been potentially detached, modified and reattached later. It is much more plausible however, that this is a later addition to the site; constructed elsewhere and moved into place on top of the surrounding clay. There are historical photographs showing the walkway on the northern side along with a retaining wall. The vertical piles appear to be the supports for the retaining wall. An additional and unlikely possibility was that it was purpose built. If so, it was an exuberant piece of construction. With three layers of planking at 20 metres long, it would have been quite heavy and therefore have been a nightmare to manoeuvre. What is puzzling about this walkway is that it does not appear to be attached permanently or solidly to the dock. This suggests it may have been a temporary structure that eventually became permanent.

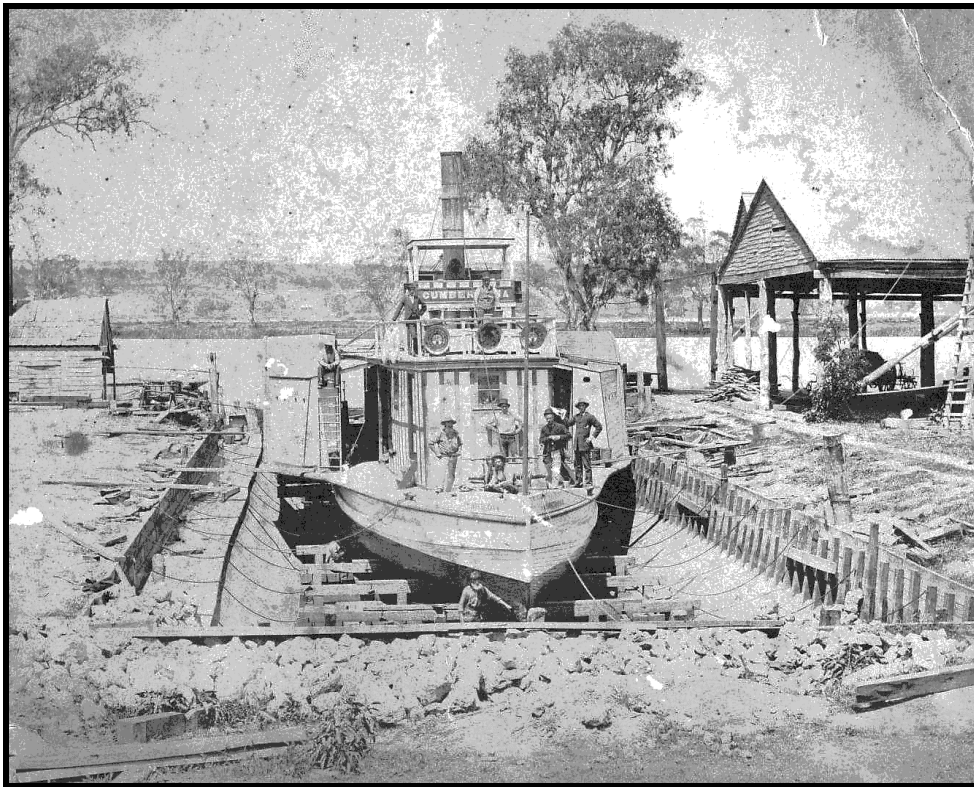
Figure 3. PS *Cumberoona* in the dock circa 1885 showing a walkway and retaining wall on the northern side (left) of the dock. (Photograph in Swanbury Penglase Architects, courtesy of the Mannum Local History Collection No.288, 2006).

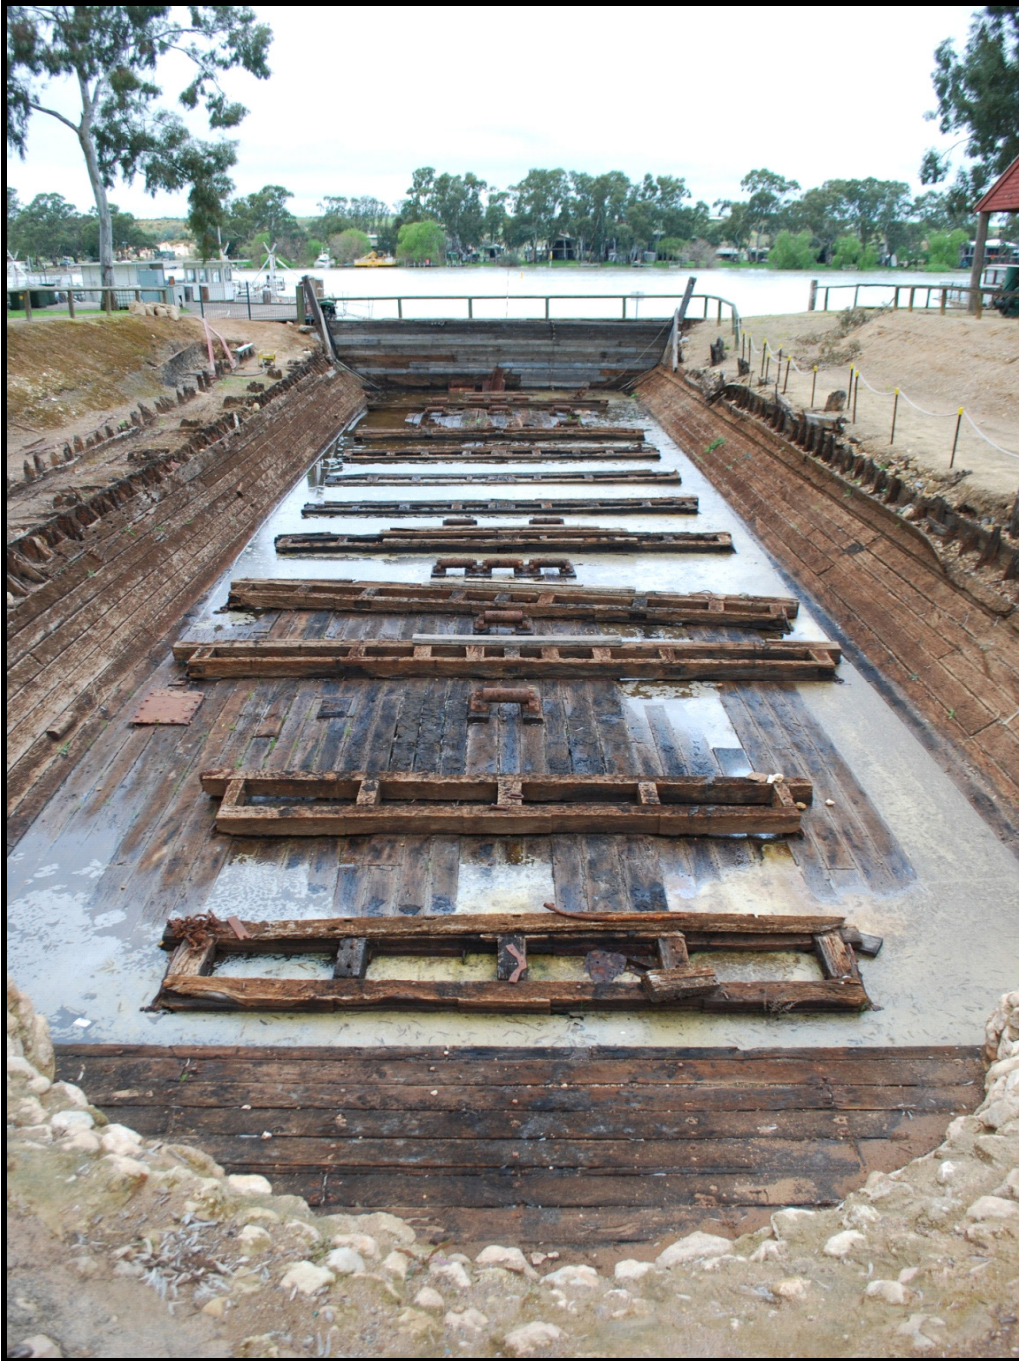
Figure 4. Looking east across the dock (Photograph by M. Fowler, courtesy of the Maritime Archaeology Program, Flinders University, 2010).
