IN SITU ARCHAEOLOGICAL EVALUATION OF THE CSS *GEORGIA* SAVANNAH HARBOR, GEORGIA

Final Report

February 2007

**Contract No. DACW21-98-D-0019
Delivery Order No. 0059
Navy Archaeological Research Permit No. PCI-2003-002**

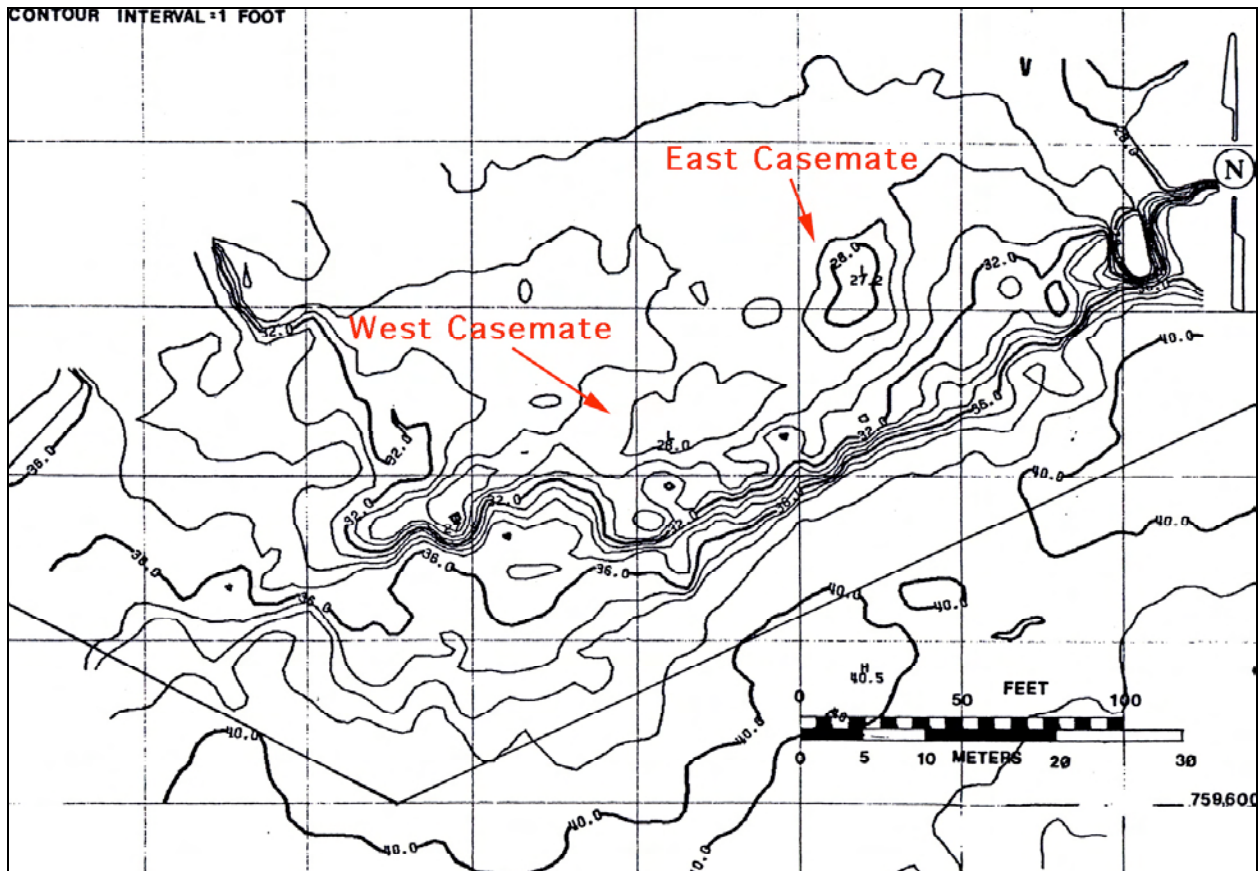
Figure 13. A standard bathymetric contour map; the top or highest point of what appears to be the West Casemate is 28 feet deep (mlw) while the top or highest point of what is most likely the East Casemate appears to be 28 to 27 feet deep (As presented in Garrison et al. 1980: Figure 35).

- Massive pieces of the casemate (greater than 200 sq. ft) extend up to 7.5 – 9.0 ft. above the bottom. No remains of the hull were found above the bottom.

- The wreckage is badly damaged along the channel side of the vessel. Debris and cultural material spread west and south from amidships into the main shipping channel. The preponderance of this debris is ordnance. Fourteen unexploded projectiles were recovered in this area.

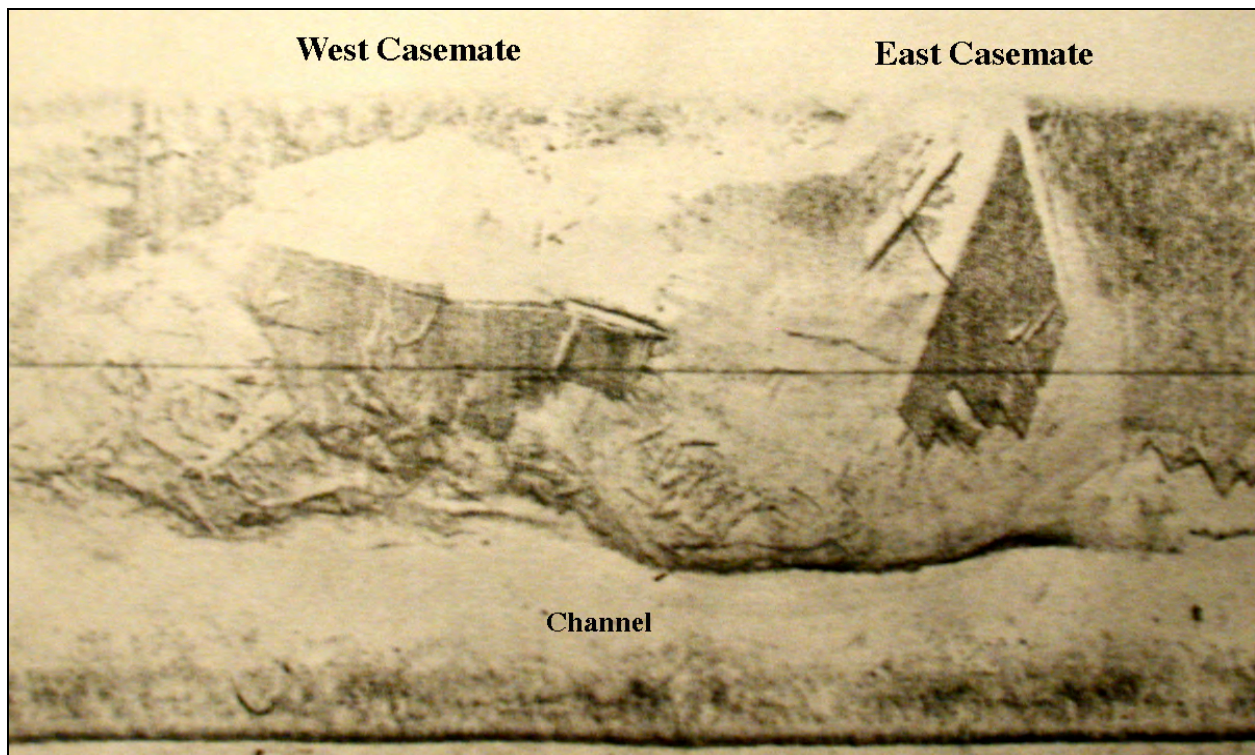
While the map is less than accurate, an acoustic image taken of the site during the 1986 investigation clearly depicts two casemate sections and an area of debris (Figure 16). Discussed below, the figure mirrors current images of the site but shows the casemate sections much more intact than they are today, indicating site degradation in the last 20 years.

Figure 16. 1986 sidescan image of the *Georgia* wreck site. Labels have been added (Courtesy of the U.S. Army Corps of Engineers, Savannah District).

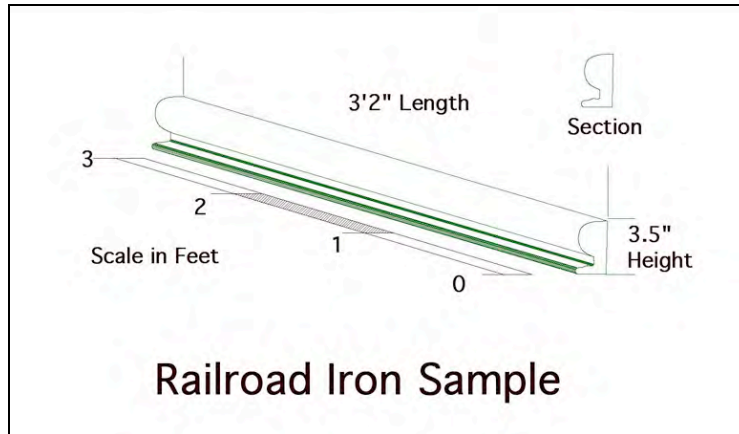
Figure 32. Sample of the railroad iron used to armor *Georgia*. Sample proved to be a short section of rail that was split longitudinally or forged as a half-rail.

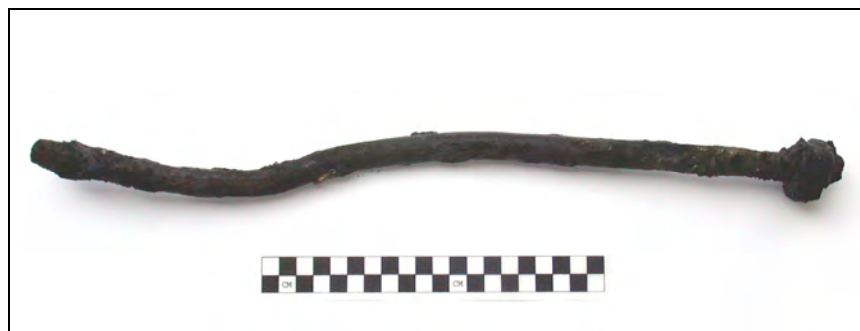
Figure 33. Fastener recovered from East Casemate. Timber backing configuration is present on the West Casemate. Thought to have originally been 23 inches in length, it fastened the armor to both layers of wood.

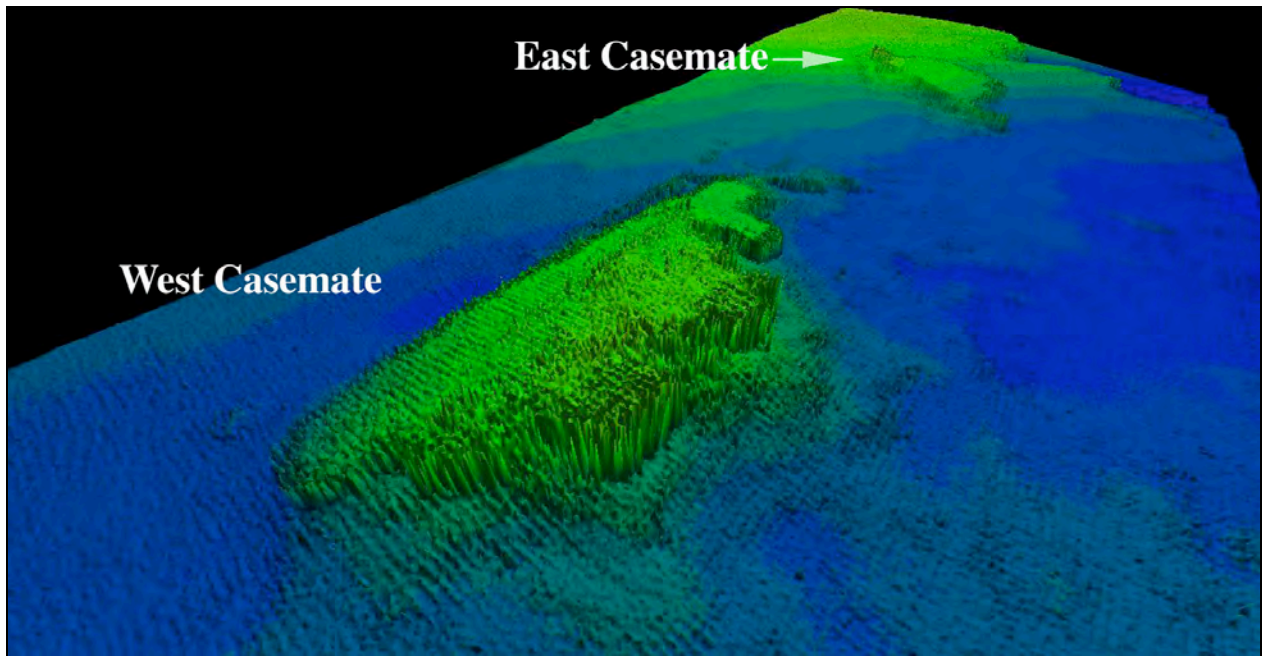
Figure 91. 2003 Reson Bathymetric oblique image of the site looking down river. Note deep dredge cuts to the left of the East Casemate (Courtesy of the U.S. Army Corps of Engineers, Savannah District).

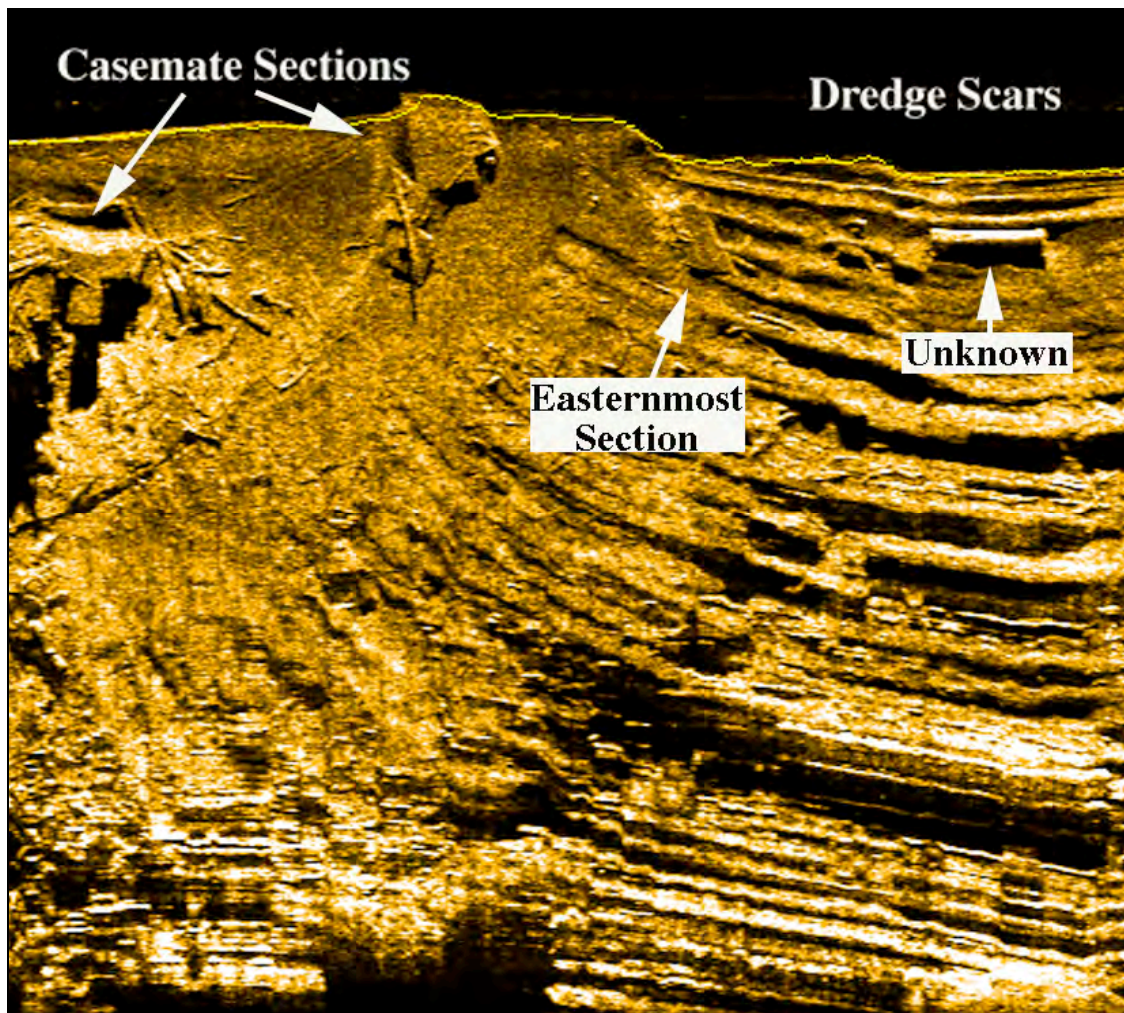
Figure 94. Acoustic image of the wreck site looking downriver (east). From left to right is West Casemate followed by the East Casemate, then the easternmost wreck section, and at far right an "unknown" (boiler?). Note linear dredge scars going just up to the Eastern Casemate; the easternmost section and "unknown" rest in the scars.

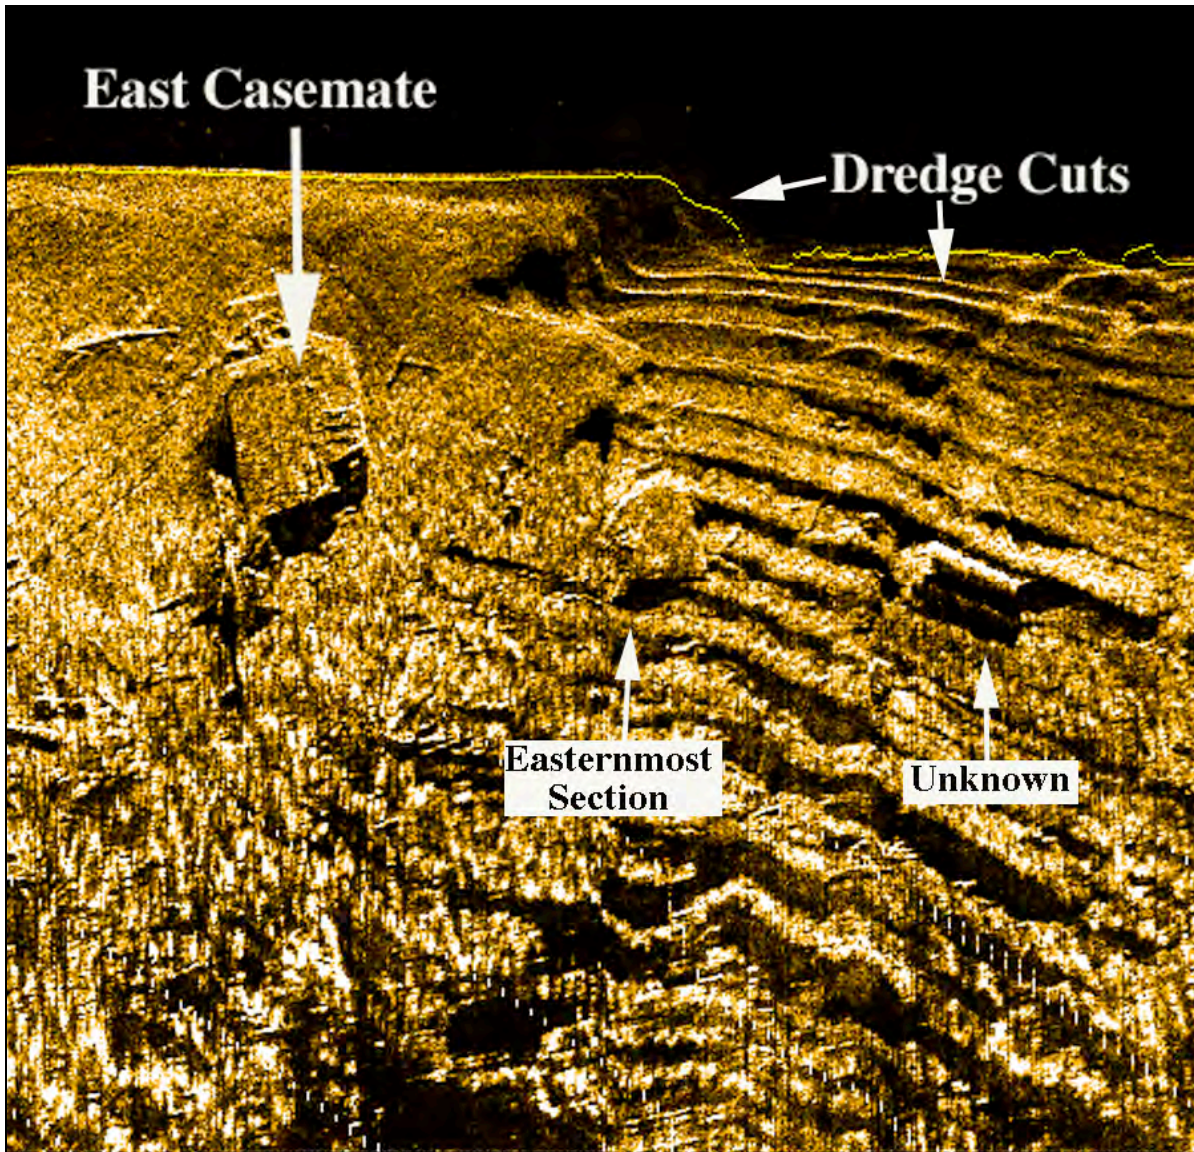
Figure 95. Acoustic image of the wreck site looking downriver (east) showing depth or height of the dredge cuts. From left to right is the East Casemate, then the easternmost wreck section and at far right an “unknown” (boiler?). Again, note linear dredge scars going just up to East Casemate; the easternmost section and “unknown” rest in the scars.

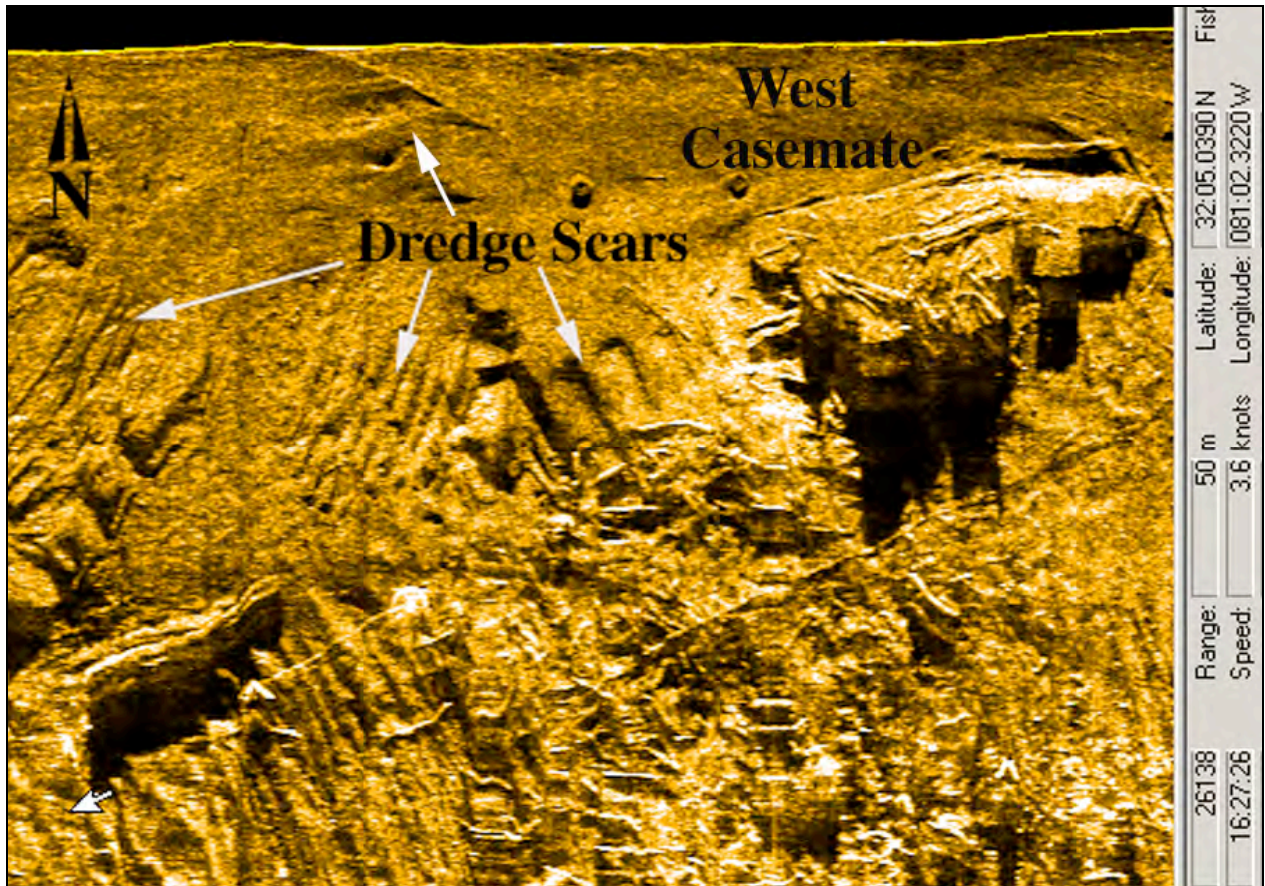
Figure 96. Acoustic image of the wreck site looking down on West Casemate. Note linear dredge scars running in multiple directions. Known as the “Debris Field,” the area to the left of and below (south) the West Casemate contains propulsion machinery (i.e. engines, propeller, shaft, etc.), and cannon that have been heavily and adversely impacted by dredging operations.

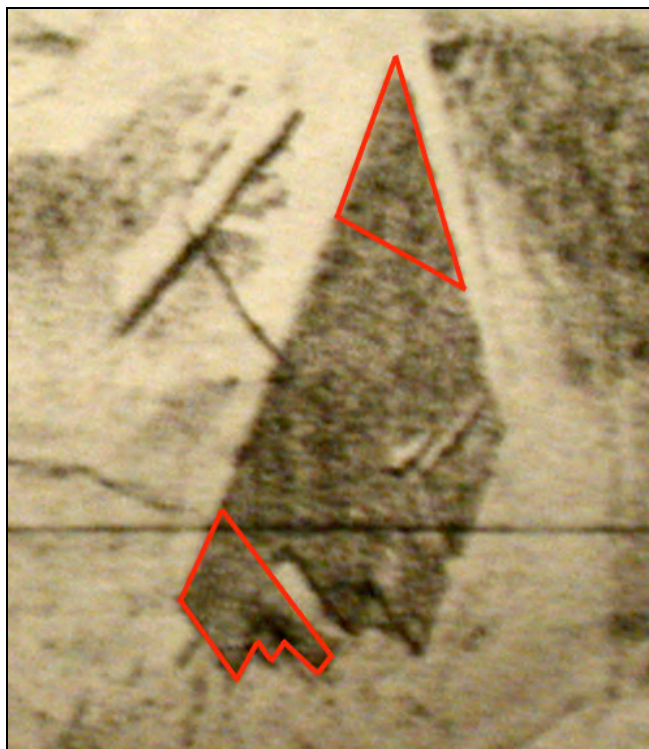
Figure 99. 1986 acoustic image excerpt showing the East Casemate section and missing or damaged areas bordered in red.

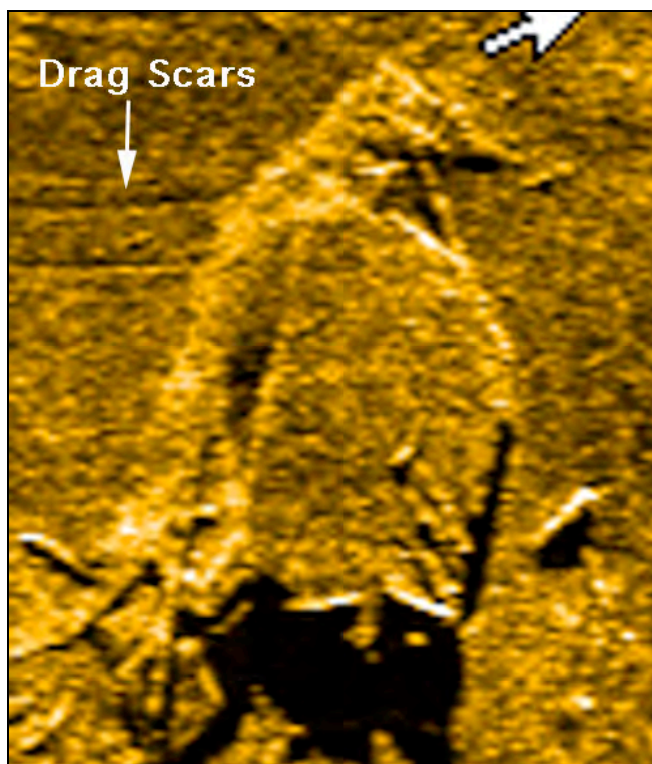
Figure 100. 2003 acoustic image of the East Casemate section. When compared to Figure 99 above, the damaged areas as well as the linear drag scars are clearly evident.

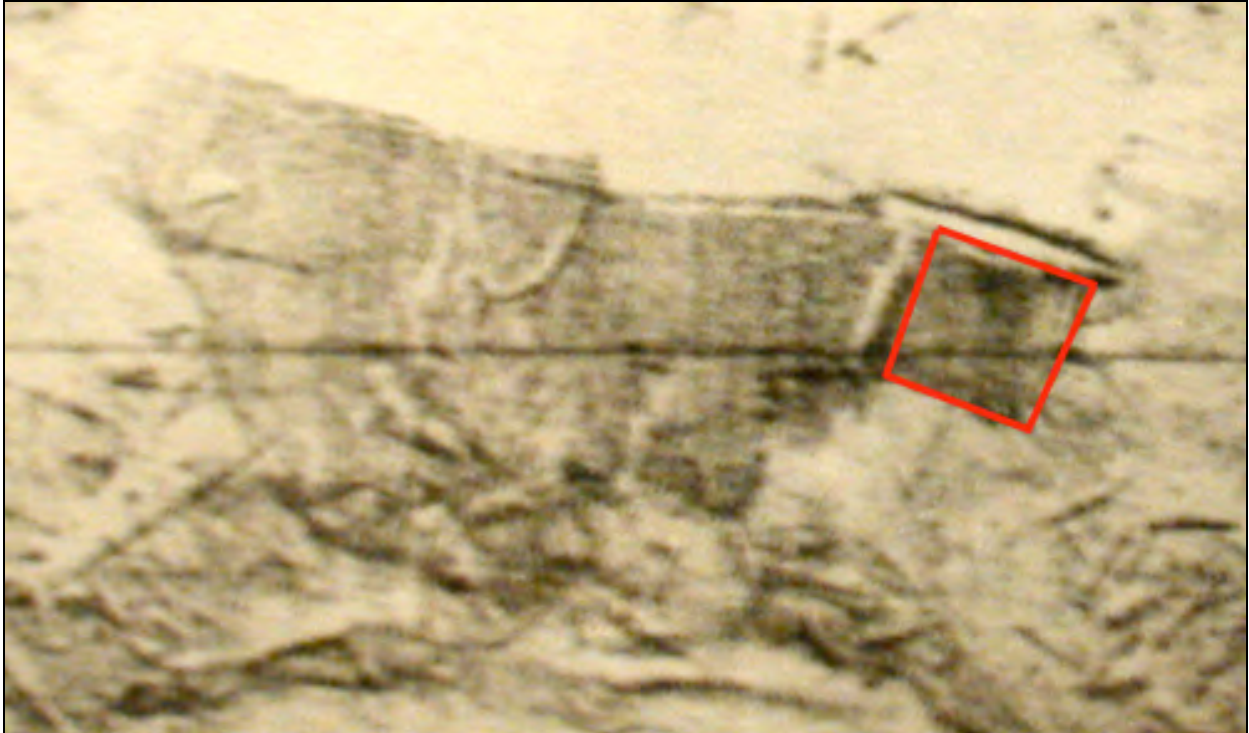
Figure 101. 1986 acoustic image excerpt showing the West Casemate section and missing or damaged areas bordered in red.

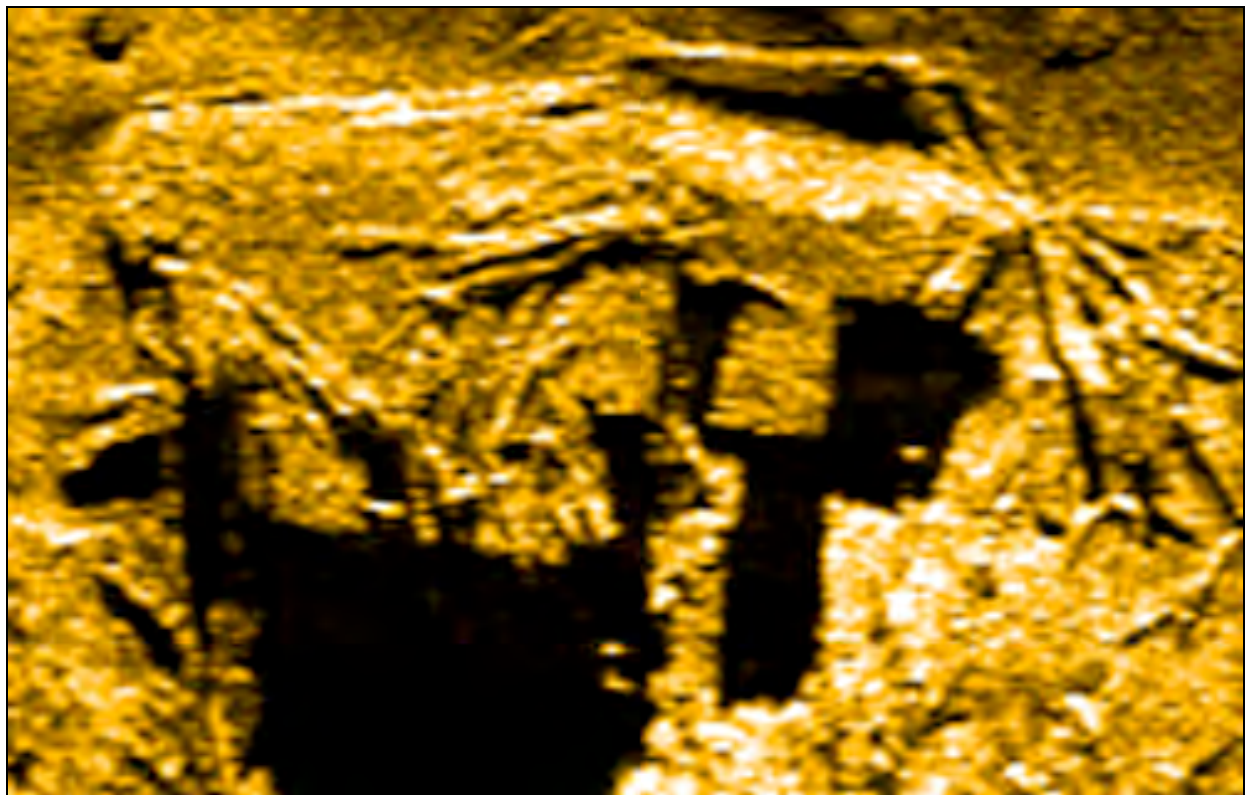
Figure 102. 2003 acoustic image of the West Casemate section. When compared to Figure 101 above, the damaged area on the right or downriver-end, thought to possibly be a result of the fouled wreck buoy, is clearly evident.
