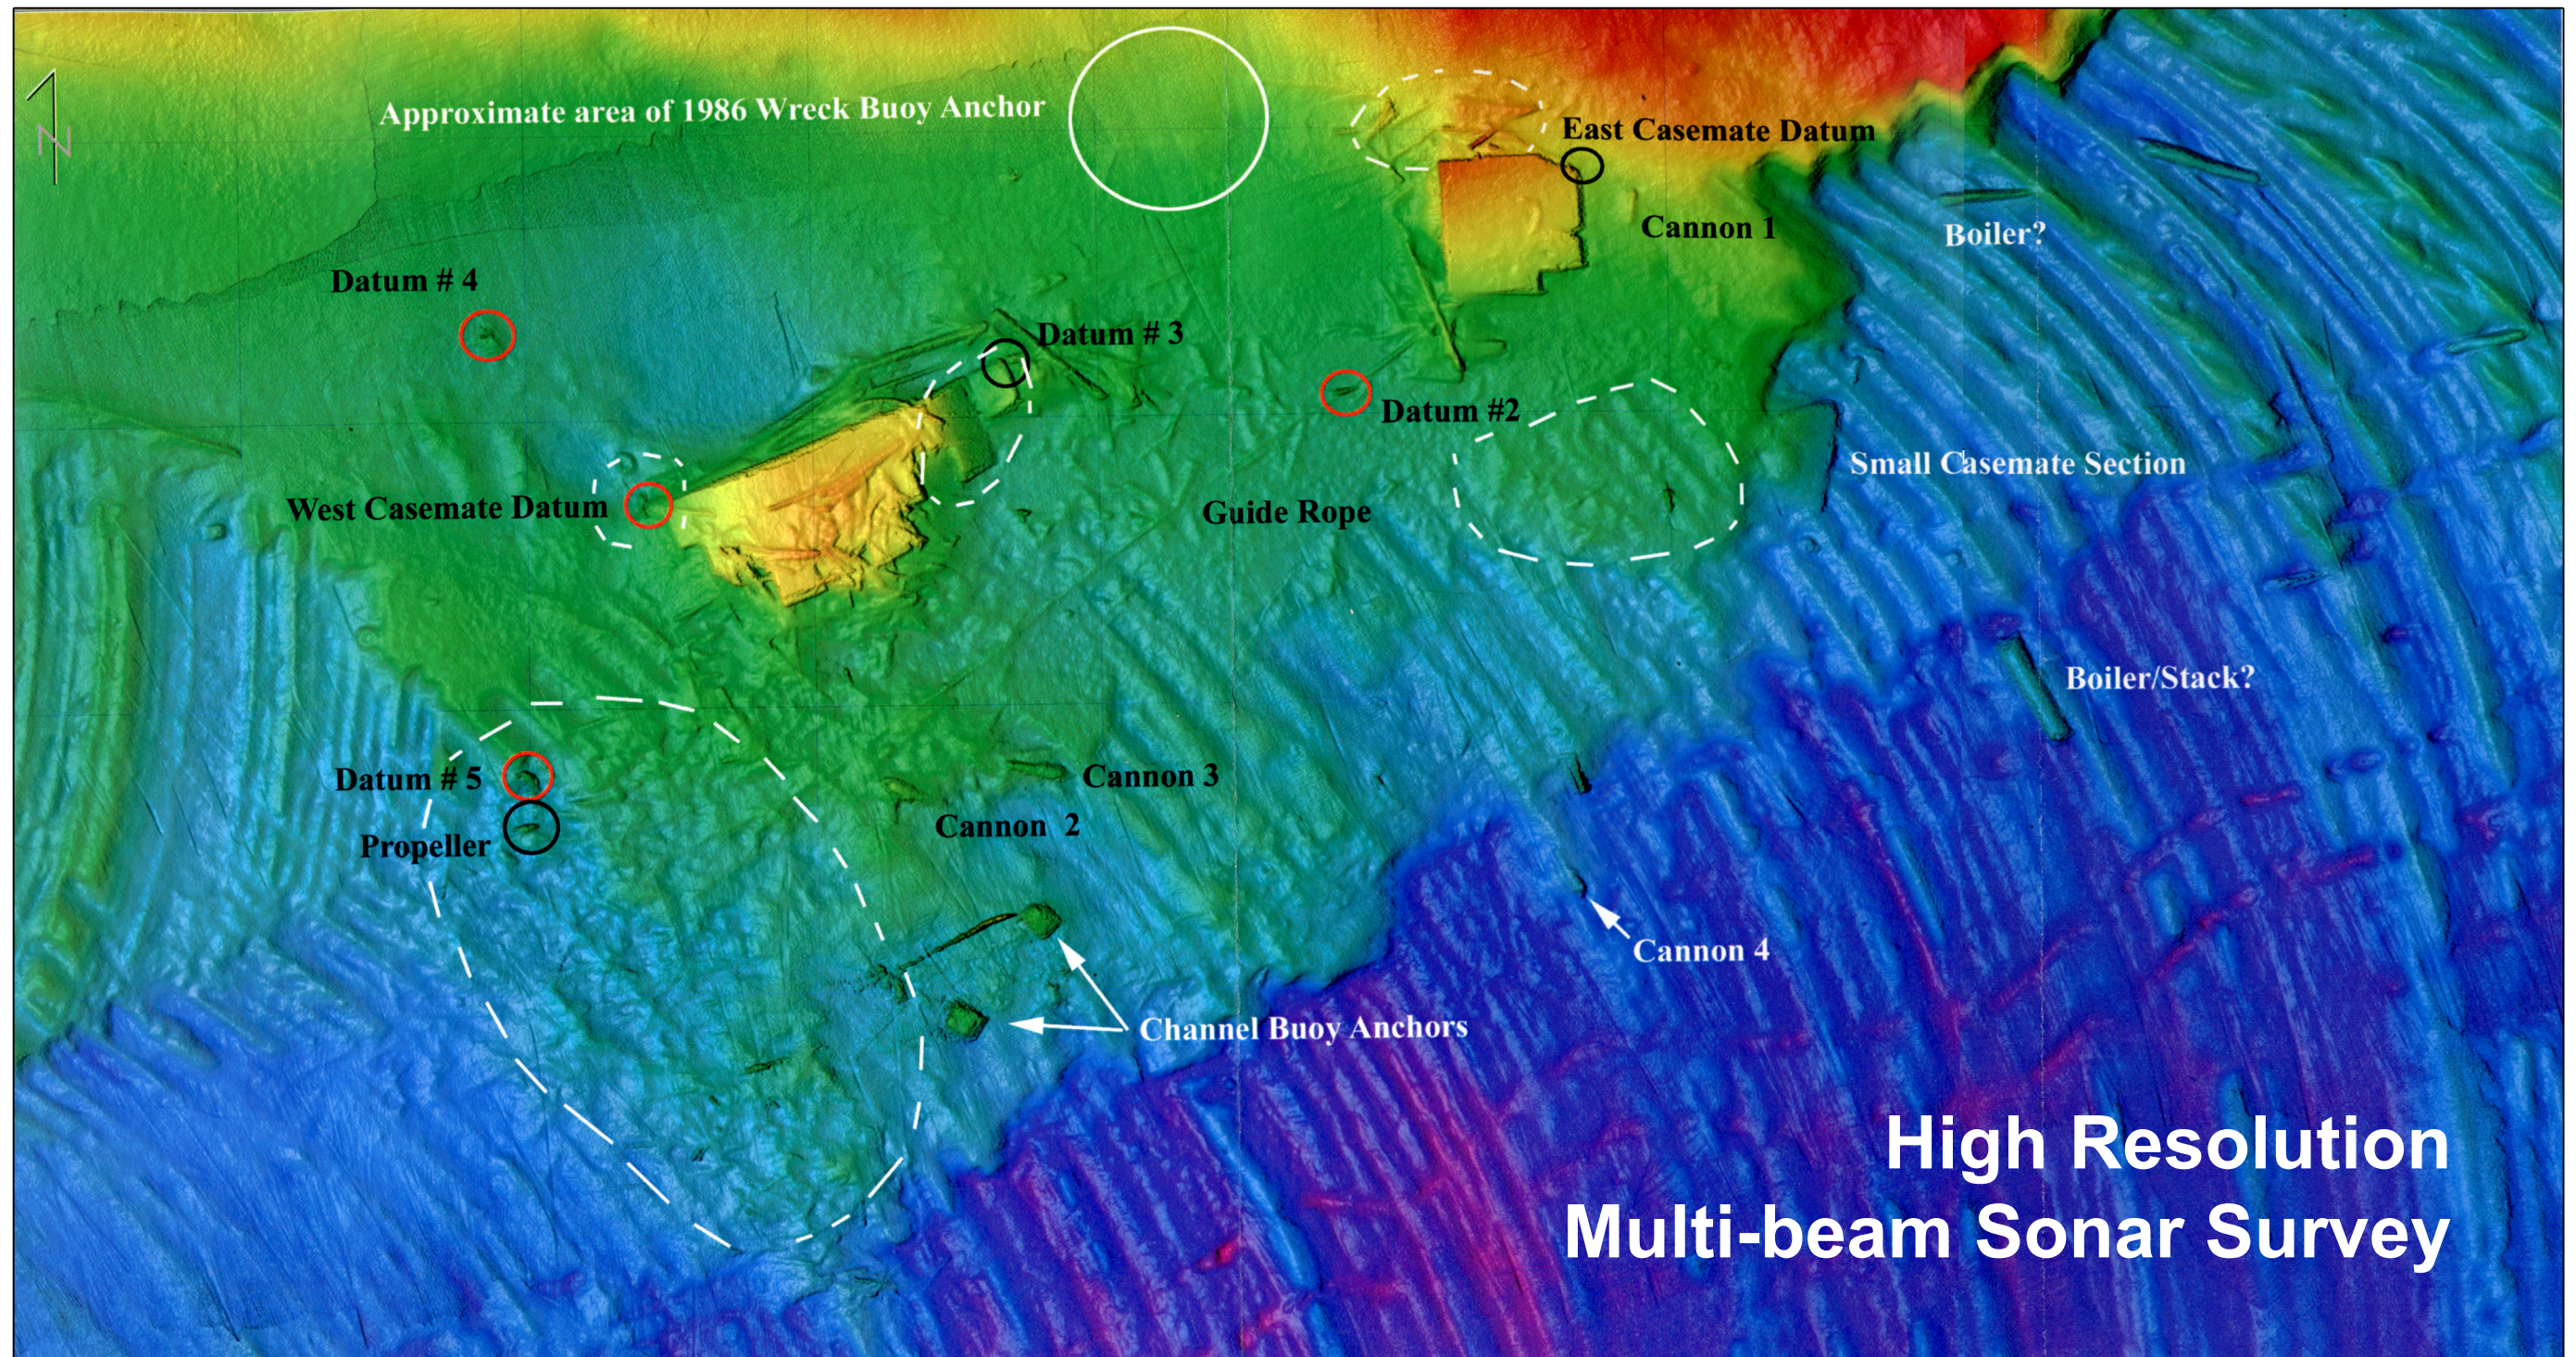
This colorful image was made in 2013 by a High Resolution Multi-beam Sonar Survey. It shows the wreck of the CSS *Georgia* shipwreck at the bottom of the Savannah River. Note how the wreck is spread across the river bottom. What remains of the vessel's casemate are the somewhat square and rectangular yellow and orange areas above. The dotted white line marks post-2003 damage to the wreck site. The Multi-beam Survey compliments the Side Scan Sonar Survey data. (Dean et al. Panamerican Consultants, Inc. 2013)
