**The Australian Historic Shipwreck Preservation Project:**  
***In-situ* preservation and long-term monitoring of the *Clarence* (1850) and *James Matthews* (1841) shipwreck sites**

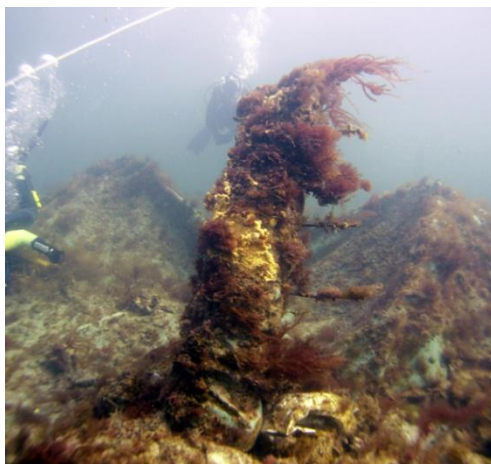
*Fig. 1 Biological growth on the Clarence site in November 2013. (J. Carpenter)*

Subsequent visits in March, September and November 2013, indicated that the *in situ* preservation strategy had been successful to date. All sand bags were still in place, there was extensive biological growth on the site and considerably more sediment build-up around the sand bags on top of the tarpaulins (Fig. 1). In addition, the sediment under the shade cloth was grey/black in colour indicating a low oxygen environment. The inspections showed that two of the higher profile ribs had broken through the protection and these will be wrapped in geotextile followed by impermeable black plastic. Any additional breakouts will be managed in the same fashion. Obviously, regular monitoring of any *in-situ* reburial strategy is essential in order to ensure continued long-term protection of the site.

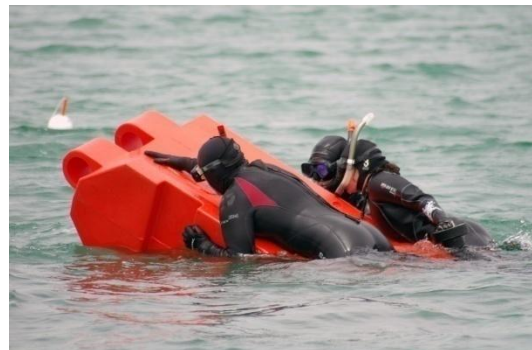
*Fig. 2 Snorkelers sinking a RCB on the James Matthews site. (P. Baker)*

Prior to the main program all previous site stabilisation equipment of anodes, sand bags and shade cloth were removed and a rope guideline was placed around the periphery of the site, which assisted in the 3 day deployment of the road crash barriers (RCBs), about 0.5-1.0m away from the wreck site in a semi-elliptical arrangement. Each RCB unit and connecting pin (0.9m length; 0.09m diameter) was filled with 20 kg and 5kg of blue metal (14mm), respectively on board a rented dive boat. The floating RCB and pin were then transported upright to the appropriate position on the wreck site using a small tender, then three snorkelers slowly sank the barrier via air displacement (Fig. 2). Two

divers received the sinking RCB and the connecting pin and physically manoeuvred the barrier into the correct position, inside the guideline and then locked it in position with the pin. The RCBs weighed approximately 15kg under water and were easily manoeuvred on the seabed.

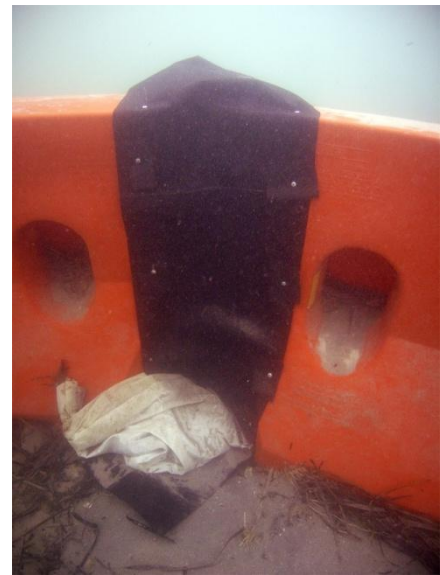
*Fig. 3 Plastic damp coursing anchored over the gaps between the RCBs with zinc tek screws. (J. Carpenter)*

deployed on-site before they were permanently anchored in place with a minimum of 120kg of blue metal per barrier. The initial sealing of the gaps in the coffer dam with 2m long; 1m wide black plastic strips proved to be ineffective due to wave action across the site so they were replaced with high density, plastic roof damp coursing (450mm width; 500µm thick) about 1.5-2.0m in length, placed over the gaps and anchored flush against the inner surfaces of the RCBs with zinc alloy tek screws (Fig. 3).

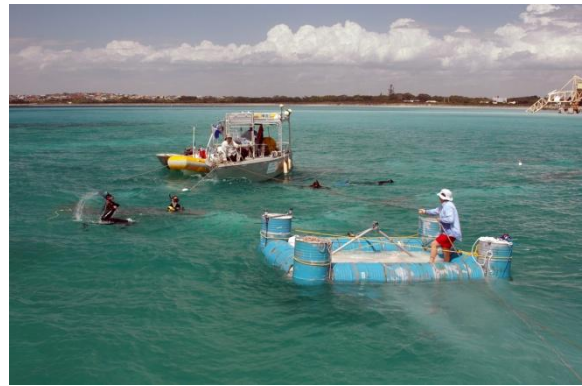
*Fig. 4 Dumping of sand from the sand barge on the James Matthews site. (J. Carpenter)*

Operation of the sand barge, designed to bring clean, washed sand to the enclosed wreck inside the RCB ring, proved that a beach based operation was not efficient since it involved multiple handling steps and took one day to deliver 3.5 tonnes of sand. The best method involved directly loading the barge from the rented dive boat moored adjacent to the site to minimise the distance the sand barge would need to be towed (Fig. 4). Twenty tonnes (1015 x 20kg bags) of sand was delivered to the site over the last two days of the fieldwork leaving 8 tonne of sand at the Museum. The second phase of fieldwork was conducted over four days in early to mid-December 2013. By direct loading from the museum truck alongside the sand barge at the nearby Jervoise Bay Yacht Club, then towing the device to the wreck site a total of 8 tonne of sand was dumped on-site in one day with only 9 personnel. Dead seagrass that had begun to accumulate within the confines of the cofferdam was placed in bags and removed from the site.

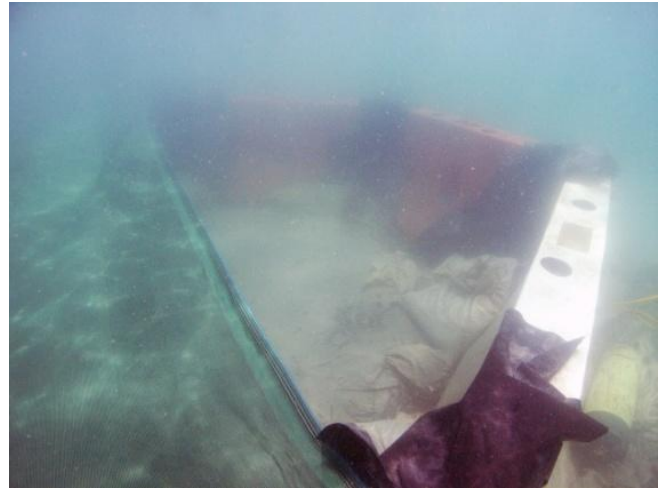
Fig. 5 The RCB cofferdam prior to the last length of shade cloth being deployed.(J. Carpenter)

A total of 165m<sup>3</sup> or 230 tonne of sand is required to achieve the desired 0.8m sediment height within the confines of the cofferdam. The enormity of this task became apparent after dumping 28 tonne of sand which only produced a 5-15cm sterile sand layer. By deploying 4m wide strips of Armashade 70% UV block shade cloth top over the top of the coffer dam it was hoped that the natural entrapment of fine sand particles suspended in the water column will assist in filling the cofferdam and also prevent ingress of dead seagrass. Seven panels with a 30cm overlap were sewn together with cable ties, which also enabled attachment to the RCBs (Fig. 5). In early 2014, the cofferdam will be filled to the required depth by dredging local surrounding sediment onto the site ensuring that minimal organic matter is incorporated within the backfilled sediment.

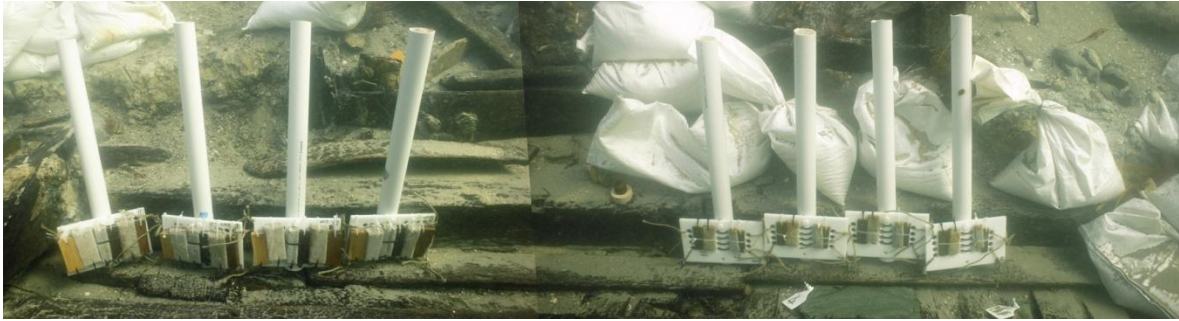
Fig. 6 The sacrificial wood and iron samples on the Clarence site prior to reburial. (J. Parkinson)

The biological and physico-chemical environment of the reburial mound should be monitored at regular intervals. Hence, the same suite of analyses will be performed on sediments recovered annually from the *Clarence* and *James Matthews* sites post reburial as was previously described for the pre-disturbed environment. However, since destructive sampling of reburied archaeological materials is inherently invasive, sacrificial modern samples, such as wood blocks and metal coupons, were included in the reburial mounds (Fig. 6).

Sacrificial wood samples and modern ferrous alloys were reburied on both wreck sites. There were significant amounts of copper alloys (e.g. fastenings, sheathing, etc) present on the *James Matthews* site, therefore duplicate copper alloy coupons were also reburied on-site. One of the duplicate wood, iron and copper sacrificial samples were wrapped in Bidim A14 geo textile to ascertain its protective effect on reburied artefacts. Each set of samples had to be reburied at least 1m apart to ensure there would be no influence of the metal corrosion products on the degradation of the wood samples and to minimize proximity corrosion.
