IN SITU ARCHAEOLOGICAL EVALUATION OF THE CSS *GEORGIA* SAVANNAH HARBOR, GEORGIA

Final Report

February 2007

**Contract No. DACW21-98-D-0019
Delivery Order No. 0059
Navy Archaeological Research Permit No. PCI-2003-002**

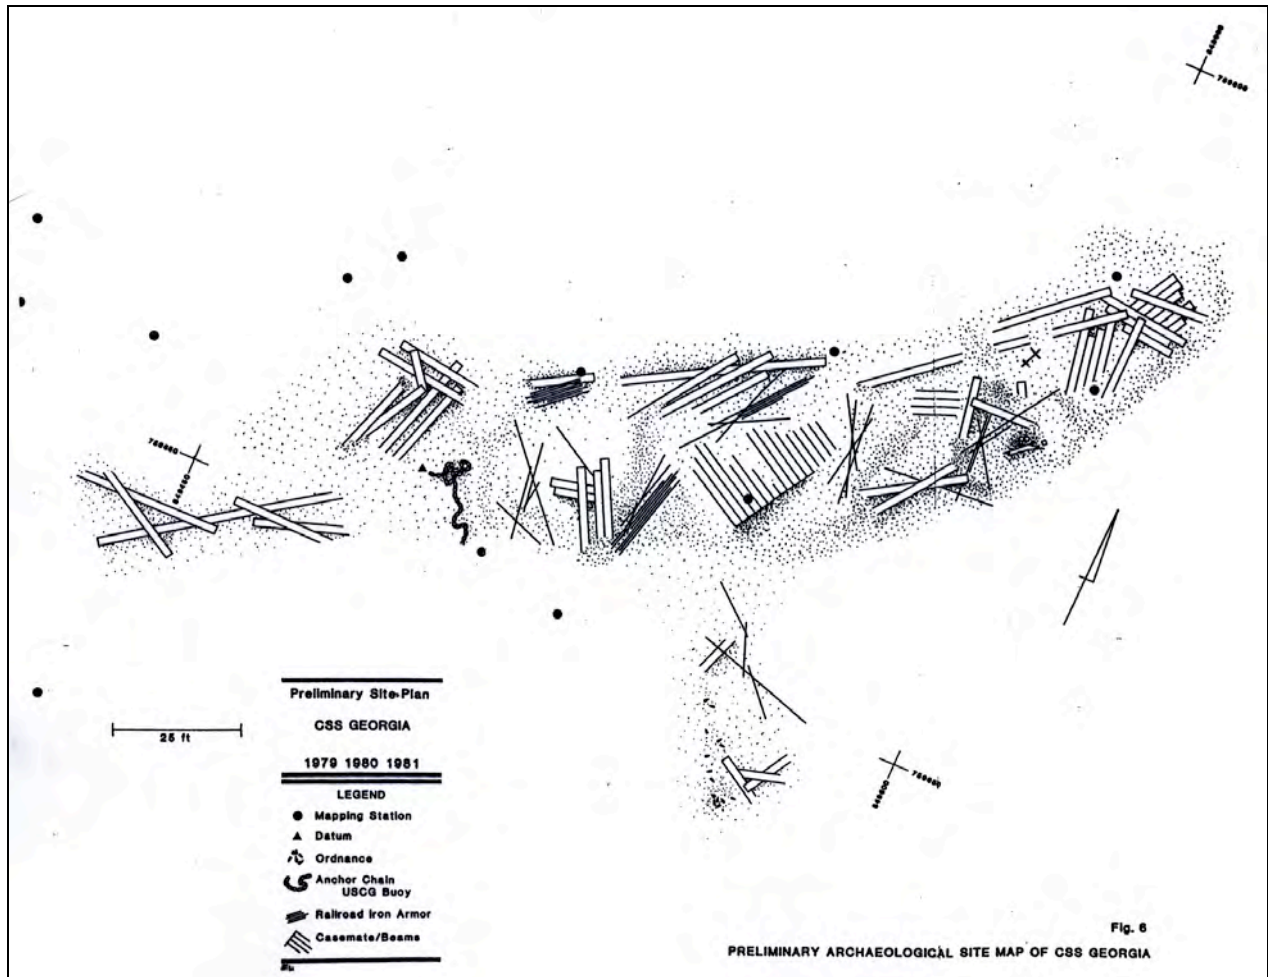
An assessment of the Preliminary Site Plan (Figure 10) presented in a subsequent 1983 Design Memorandum and produced with data from the 1979 archaeological study, indicates that the site plan is mostly conjecture and seems to highlight the paucity of hands-on site data obtained during this early study. Interestingly, large sections of above-sediment wreckage that appeared on an acoustic image of the site and presented in the 1979 fieldwork report are not represented on the site map (Figure 11).

Figure 10. Preliminary *Georgia* site plan (As presented in U.S. Army Corps of Engineers 1983:VI-9).

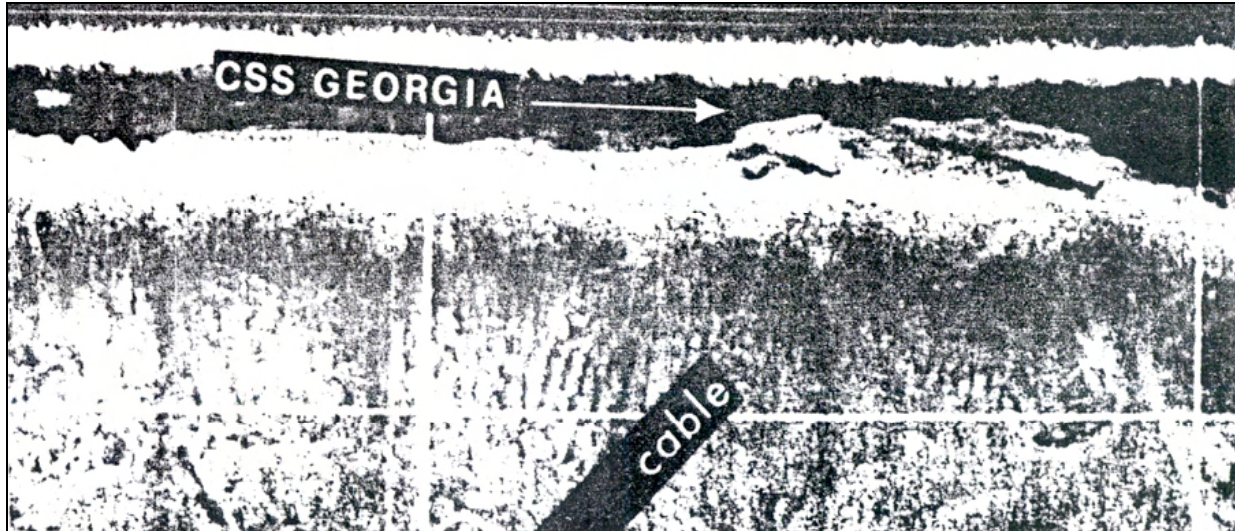
Figure 11. Acoustic image showing large sections of wreckage thought to be the West and East Casemate sections. These, however, are not represented on the 1980 site map (As presented in Garrison et al. 1980:Figure 39).

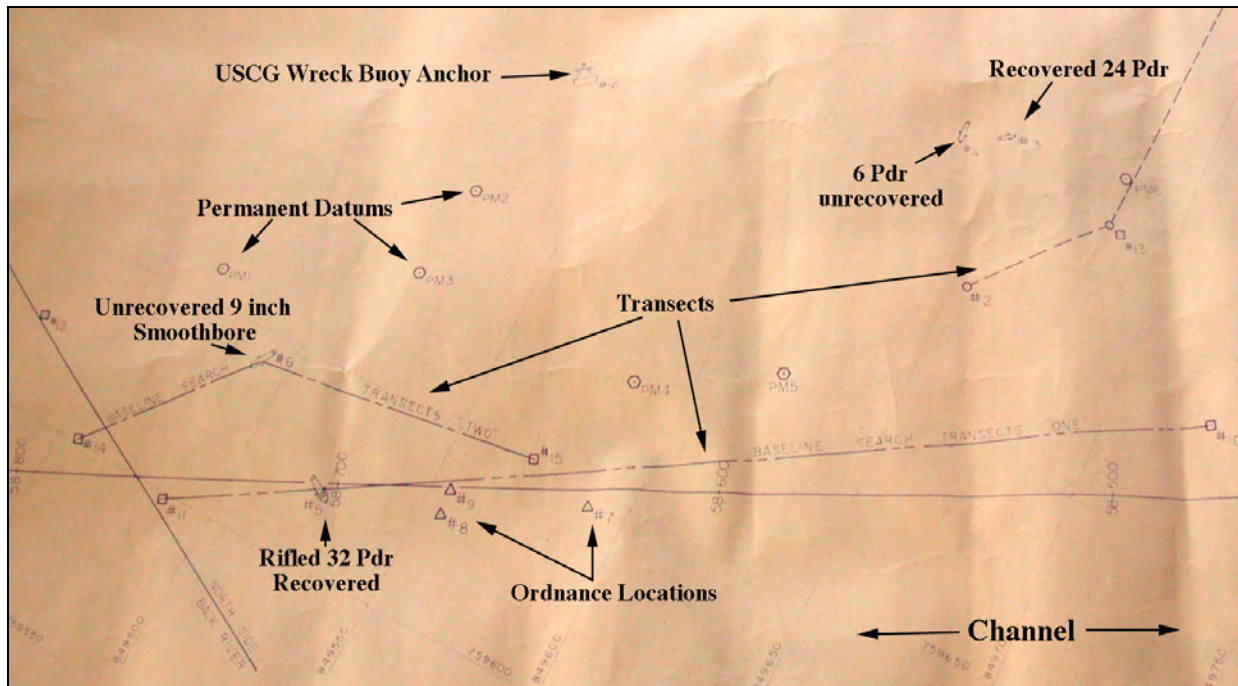
In 1986, diving operations were conducted by the District during which time four cannon were located on the site. Two of these cannon and numerous projectiles were recovered from the wreck site and others were located but not removed (Judy Wood, Personal Communication 2003). Presented in Figure 15, a site plan was produced that shows the locations of the cannon and ordnance. However, based on our own findings (see Findings chapter below), the preliminary site plan produced from the 1986 study appeared inaccurate relative to location information for the guns, and made recreation of their 1986 locations problematic at best.

Figure 15. Excerpt from the 1986 site plan produced by the Savannah District during diving operations at the *Georgia* wreck site. Not depicted on the map, the East Casemate section would be generally located at the upper right near the unrecovered 6 pdr, and the West Casemate would be generally located above the unrecovered 9-inch smoothbore, above and adjacent the “Permanent Datums” (Courtesy of the U.S. Army Corps of Engineers, Savannah District).

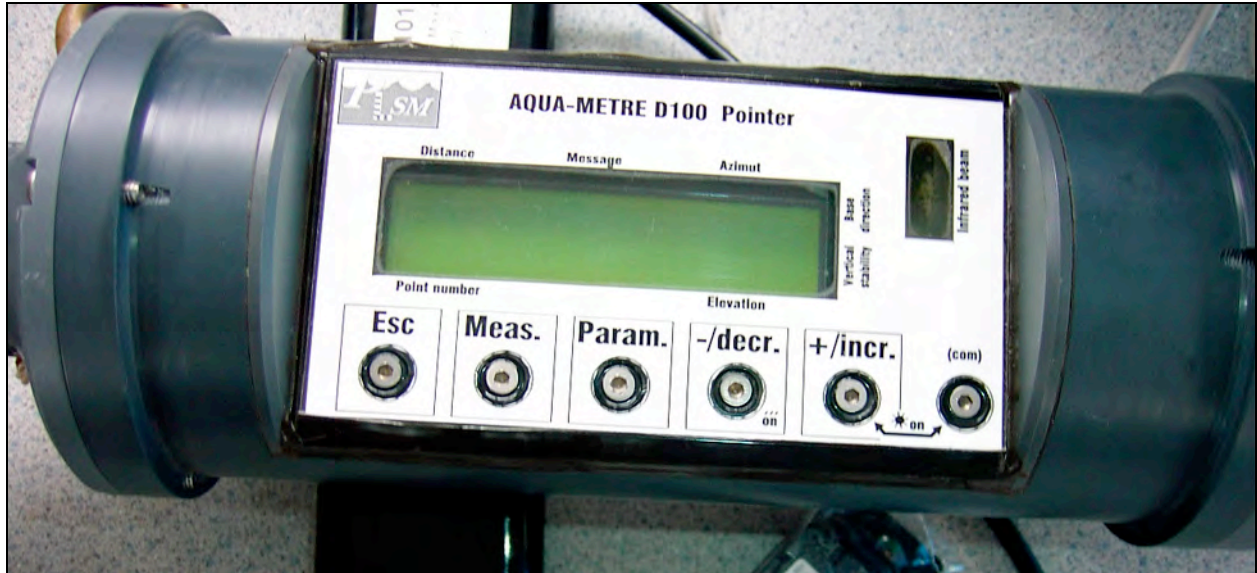
Unfortunately, a number of problems were encountered with the system. Water column noise that also impacted high-resolution towed sonars degraded the signal in spite of efforts to blank the interference. Difficulty in seeing the transducer display in reduced visibility also hindered operations. When problems were encountered with both the battery life and programming software, efforts to use the system were abandoned in favor of more traditional methods of mapping (i.e. triangulation with hand-held tapes). With that said, numerous measurements were obtained with the system, and when cross-checked with the more traditional methods, the measurements were found to be accurate in many cases but not all.

Figure 25. Photograph of the Aqua Metre D100's hand-held, diver-operated transducer. The LED transducer display screen that would indicate when a reading had been obtained was often difficult to read by the diver in the low visibility conditions present on the wreck site.

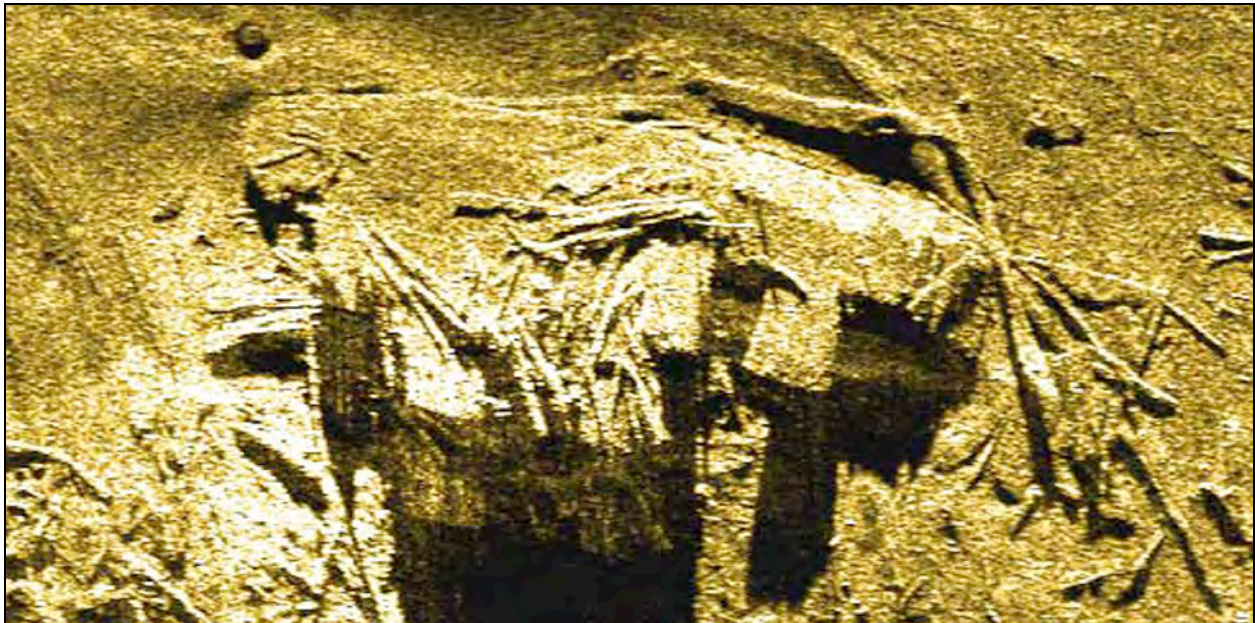
Figure 28. Acoustic image of the West Casemate.

The opposite southern side that faces the channel is heavily disturbed and fragmentary. That disturbance is most likely representative of impacts from past channel dredging. With the exception of several sections or lengths that can be seen lying loose on top, as indicated on the acoustic image in Figure 28, the upper surface of the northern half of this casemate section is smooth and represents intact armor that runs in lengths from north to south or along its width. Comprised of interlocking railroad track or “T” iron, the armor along the southern edge has a “splintered” appearance where the railroad iron is splayed apart. Not as wide as its upstream half, the channel side, downstream portion of the articulated section of casemate has several clean angular breaks appearing almost as-built to some degree. These have been tentatively identified as portions of gunports.

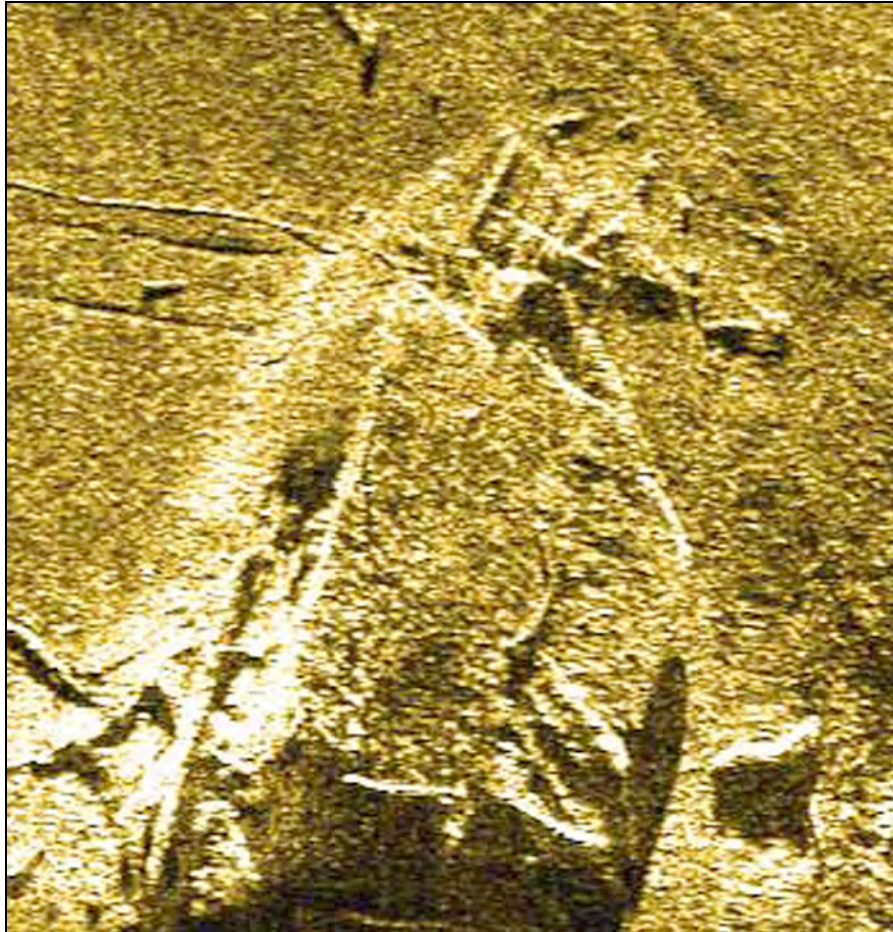
Figure 29. Acoustic image of the East Casemate. Note Cannon No. 1 at lower right corner.

The second most prominent feature of the *Georgia* wreck site is the East Casemate section. Like the West Casemate, it represents a section of the vessel’s timber-backed armored side. Again, like the West Casemate, it is unsupported by the no longer extant hull. The section is slightly pedestaled, and generally lays flat on the bottom. Its west and east sides appear to be as-built as does is angled northeastern edge. However, the extreme northern tip and the channel or southern side are somewhat disarticulated. Damage to the southern side is most likely representative of impacts from past channel dredging activities. The distance between the west and east as-built sides is 24.3 feet. The orientation of the rail iron is east and west, the rails and their orientation visible on the acoustic image in (Figure 29). The overall length of the section (north to south) is 37 feet.

The northeastern edge, seen as a short as-built 8-foot angular run on the acoustic image in Figure 29, is composed of the ends of rail placed in a descending stepped fashion that angle downward 45° from the as-built downriver edge. This construction characteristic argues that the vessel had angular faced or faceted ends, suggesting that this section of casemate would have formed one of the forward or aft corners, either representing the side of the casemate, or perhaps the forward or

aft face. The remains of a feature identified as a gun port are present on the southern damaged edge of this section. With a squared base and a curved top, it is 4.1 feet in height (a remaining width measurement was not obtained). Co-Principal Investigator Gordon Watts dove on this section 15 years prior and since that time this gun port, which was complete at the time of his first dive and only shoulder-width wide, has all but disappeared. At that time, the two casemate gun ports identified during the dive measured 2 feet in width and 5 feet in height.

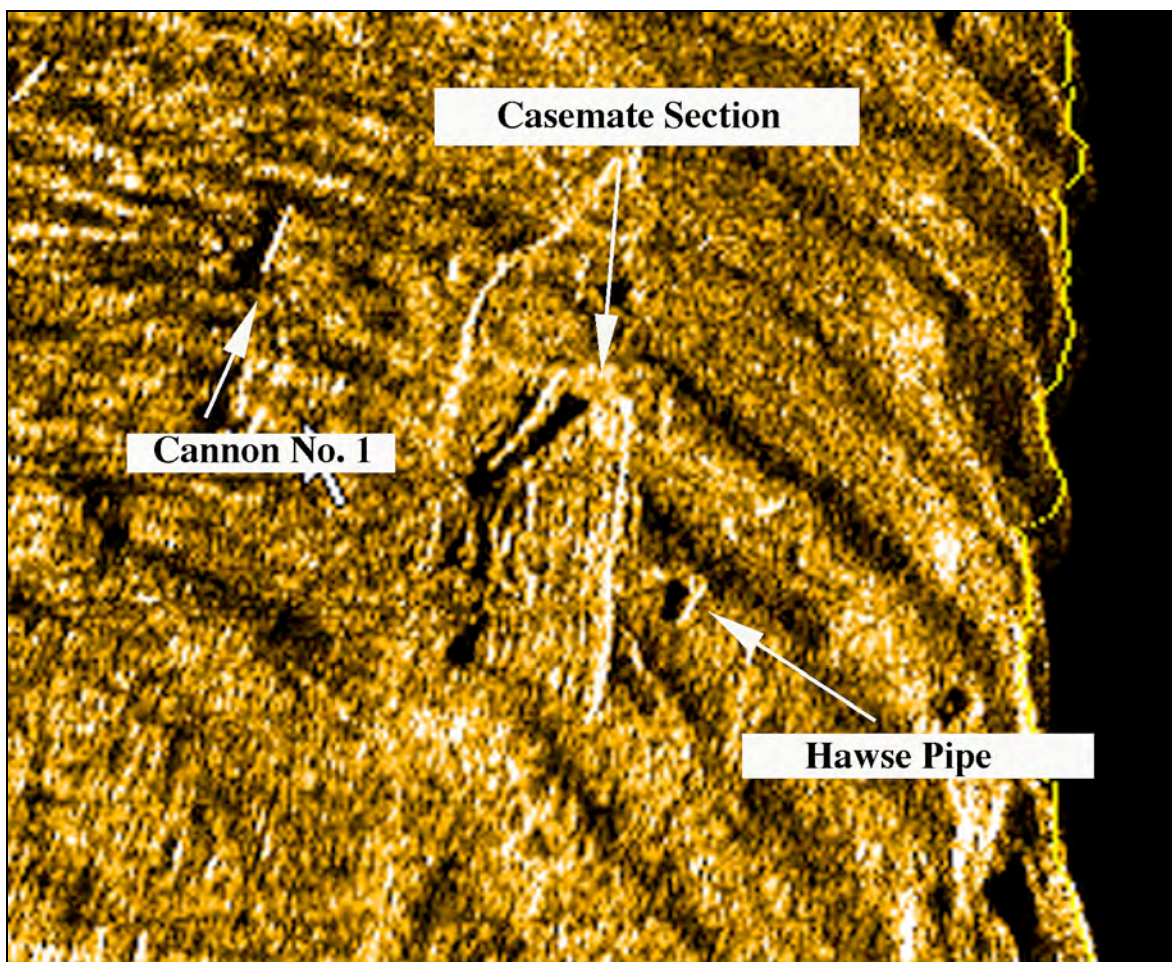
Figure 34. Acoustic image of the third and smallest Casemate section.

The area directly south of the East Casemate and arching into the channel for a distance of 100 feet was searched for what appeared to be a third piece of casemate. Although not as large or visually pronounced on the acoustic images (Figure 34), it did appear as an articulated section of the vessel worthy of investigation. Located approximately 66 feet from the East Casemate Datum to the southeast and in an area of 4-foot deep dredge scars. This element of vessel structure lies flat on the bottom, is similar to the other casemate sections in that it has multiple edges of varying angle and length. Generally speaking, it currently has five edges (not as-built) and is approximately 11-feet wide and 18-feet long, with the timber backing facing up. Numerous fasteners project upward from the badly deteriorated timbers (several layers), which are in turn attached to rail cladding underneath. The rail lengths run in a direction from the channel to the north (aligned with the dredge scars). This section appears to have been directly impacted by dredging.

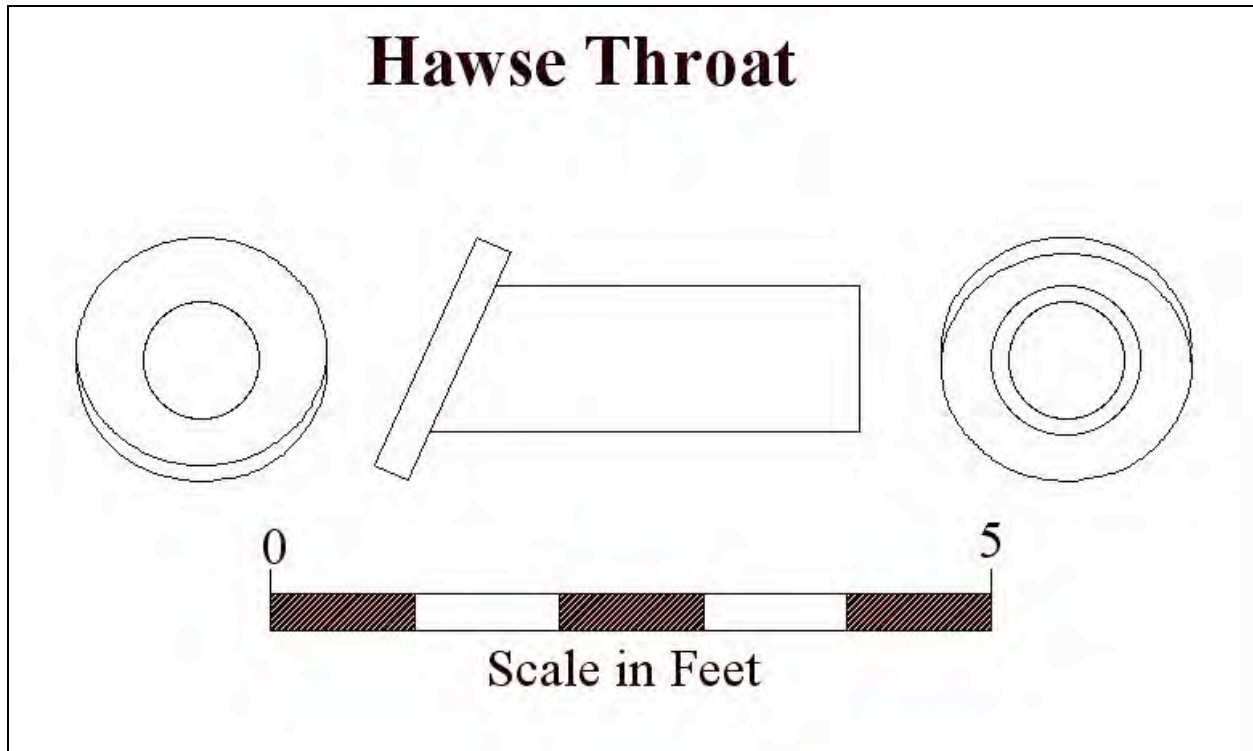
Located approximately 7 feet down-river from this section is a 3 foot 4 inch-long cylindrical iron object believed to be a hawse throat or pipe. Hollow, it is asymmetrical in that one end has a diameter of 12 inches while the opposite end has a mounting flange with a diameter of 17 inches. The mounting flange appeared to be cast at roughly 30 degrees off perpendicular to the longitudinal axis of the pipe (Figure 35).

Figure 35. AutoCAD line drawing of long cylindrical iron object believed to be a hawse throat or pipe.

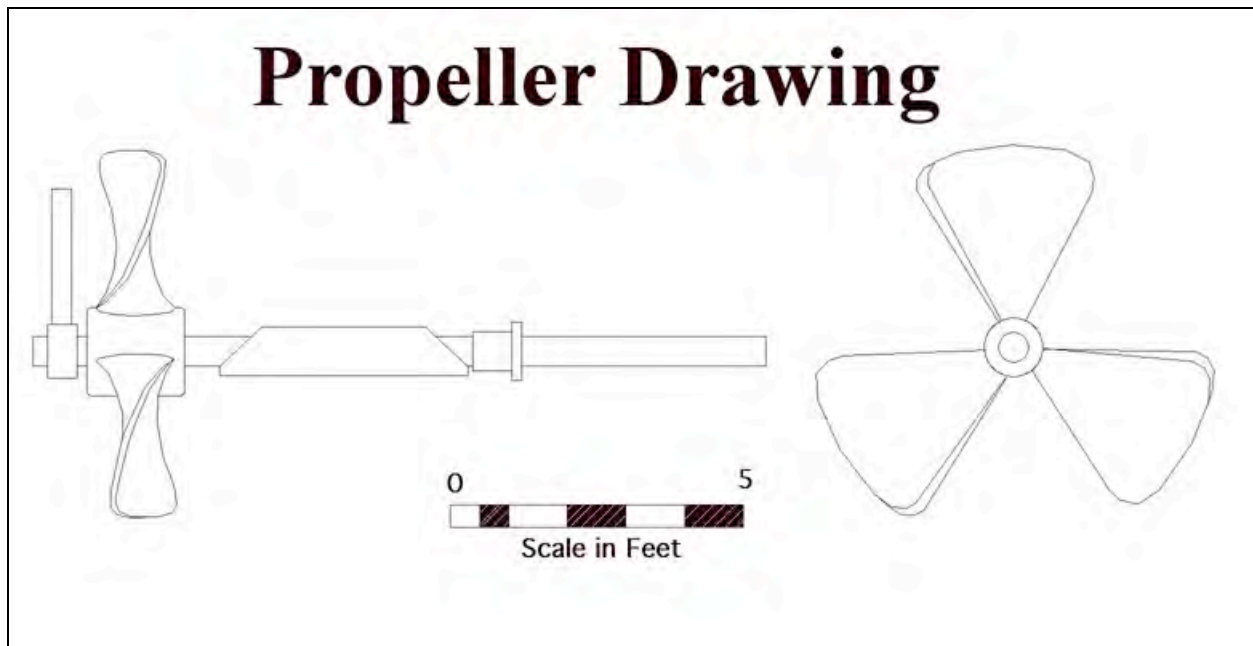
broken off or extends into the bottom. Illustrated in Figure 36, the exposed blade has a height of 3-feet 9-inches from the shaft to its tip and a maximum width of 2 feet. The base of the blade is 20 inches in length where it projects from a 1-foot 8-inch long and 18 inch diameter hub. The shaft diameter is 6 inches and it has a remaining length of just over nine feet forward of the hub. Forward of the hub is a stuffing gland, and aft of the propeller is a 1.5-inch thick collar. Aft of this collar is a 2-inch diameter pin or key. Thought to have been a three-bladed propeller, the angle of the blade indicates that it turned clockwise, and the size of the screw would suggest that the vessel originally had two propellers as was indicated in the historical record (see Swanson and Holcombe 2003:74). If the vessel did indeed have two propellers, then it is safe to assume, like those found on other similar vessels, that the propellers turned outward on each side of the rudder. Our propeller would then be identifiable as the starboard propeller.

Figure 36. AutoCAD line drawing of propeller and shaft.

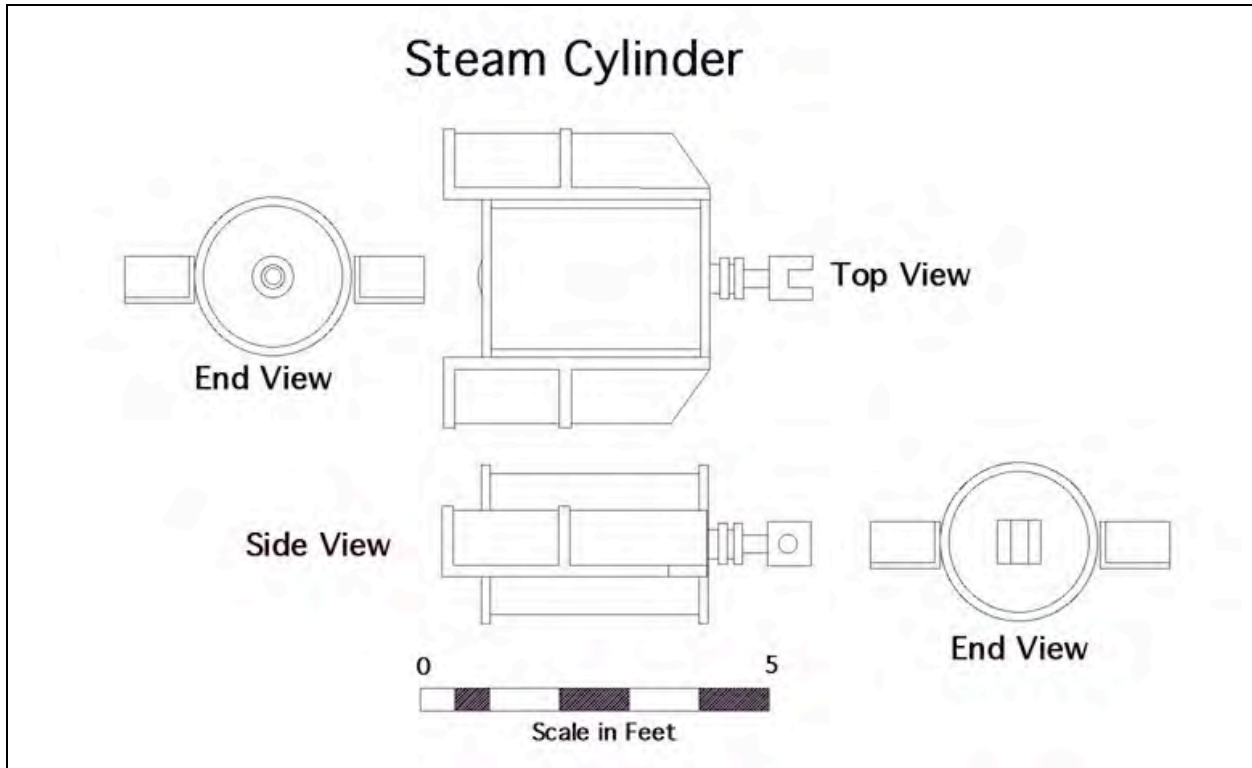
Archaeologists located what appear to be two steam cylinders. Both are clearly horizontal cylinders associated with CSS *Georgia*'s propulsion. The third cylinder is of decidedly different dimensions and design and is most likely a condenser or mud drum. Cylinder No. 1 was located slightly downriver and in channel 50.5 feet from Datum 5 (adjacent propeller) and 30.5 feet upriver from Cannon No. 2 (Figure 37). The design is clearly one of a horizontal direct acting engine. Sticking out of the bottom at approximately a 45° angle, the single cylinder has an overall length of 39.5 inches, and the ends have a diameter of 24 inches. Bent at a 90° angle where it comes out of the cylinder, a 3-inch diameter piston rod projects 26 inches (remaining length from the stuffing gland) on one end of the cylinder. The face of the opposite end has a 3.5-inch diameter, upward-projecting dimple suggesting this is the top of the cylinder. Both end caps are bolted along their outer rims with hex nuts spaced on 8-inch centers.

Cylinder No. 2 lies approximately 10 feet away and toward the channel in a noticeable dredge scar, Cylinder No. 2 is also thought to represent one of the vessel's steam engines. Similar in size and shape to Cylinder No. 1, this cylinder also has an overall length of 39 inches, and the ends

have a diameter of 24 inches. It has a similar dimpled end opposite the piston rod end. Unlike Cylinder No. 1, this cylinder's piston rod is all the way in the cylinder. Projecting slightly from the now-broken stuffing gland, the piston rod end has an in situ "wrist pin," for attachment to the crosshead. Mounting brackets are located on opposite sides of the cylinder.

Figure 37. AutoCAD line drawing of Cylinder No. 1, one of the vessel's steam engines. Cylinder No. 2 is similar in size and shape.

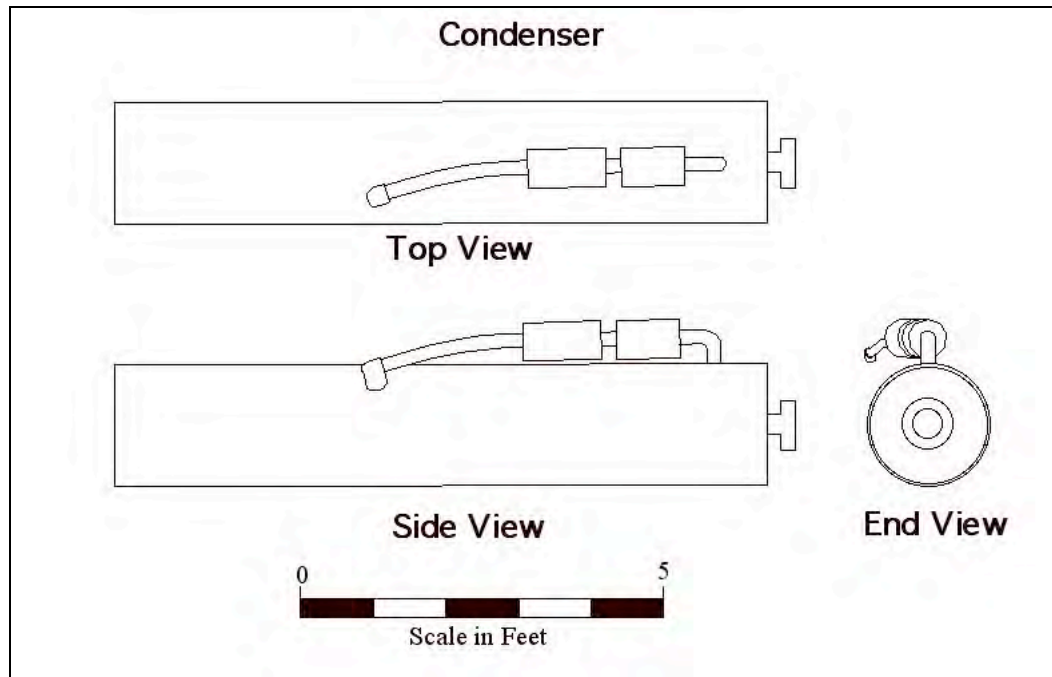
A third cylindrical object was located immediately adjacent to and slightly underneath the upstream side of Cannon No. 2. With a total overall length of 9 feet and a cylinder diameter of 20 inches, Cylinder No. 3 is much larger than the two steam cylinders. It has attached piping and a valve along its upper side. Although the flange is partially broken, the end adjacent the cannon has a 3-inch diameter hole in its center. In all likelihood this cylinder represents a condenser (Figure 38).

Figure 38. AutoCAD line drawing of “Cylinder No. 3” located adjacent to Cannon No. 2. Of decidedly different dimensions and design from Cylinders 1 and 2, it is thought to represent a condenser.

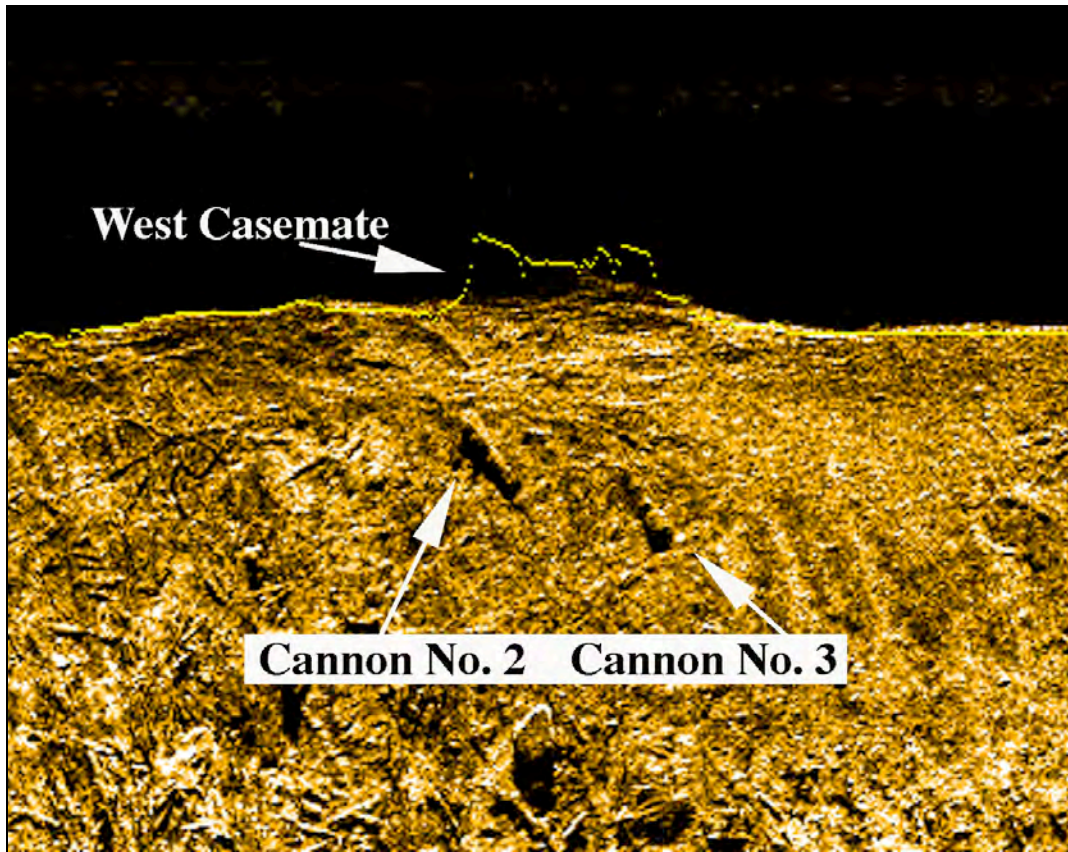
Figure 39. High-resolution sonar data of Cannon Nos. 2 and 3 that helped to focus search areas.

With its muzzle pointing toward the West Casemate, Cannon No. 3 is situated just over 22 feet downstream from Cannon No. 2. With a total length of 10 feet 8 inches and a maximum diameter of 2 feet 2 inches, its flaring muzzle has a 5.5-inch bore diameter (concreted). The gun has a single reinforcing band 25.5 inches in length around its breech, and its cascabel has a 3-inch diameter hole through its center (Figure 42). What appear to be parts of a gun carriage are located near this gun. A 6-foot long iron rod with 2 circular objects, possibly wheels, lie 4 feet from the muzzle.

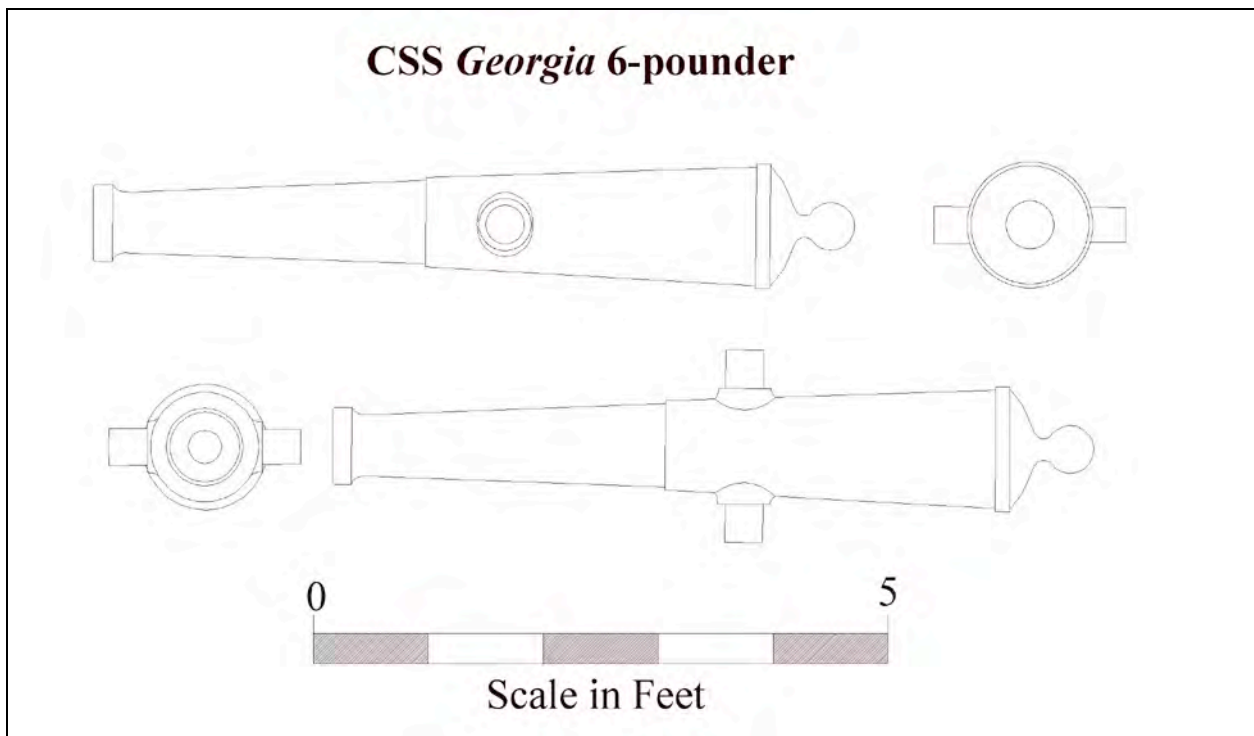
Readily discernable in the acoustic imagery shown in Figures 26 and 29, Cannon No. 1 is located 9 feet downriver from the East Casemate. Oriented with its flaring muzzle upriver and its cascabel downriver, the cannon sits on its side with one of its two trunions pointing upward (Figure 40). Most likely a 6-pounder, Cannon No. 1 is 6-feet 5-inches in total length, and has a bore diameter of 3.5 inches (cleaned of concretions). If our identification as a 6-pdr is correct, then it most likely represents the 6-pdr stated as being presented for use on *Georgia* by the Ladies of Rome, and originally positioned on the vessels’ Spar Deck Aft (Swanson and Holcombe 2003:84-85). Although the bore indicates that the piece is a 6-pounder, the style resembles a 24-pounder Siege & Garrison Howitzer Model 1844 (Ripley 1970:49).

Figure 40. AutoCAD line drawing of Cannon No. 1, a 6-pounder.

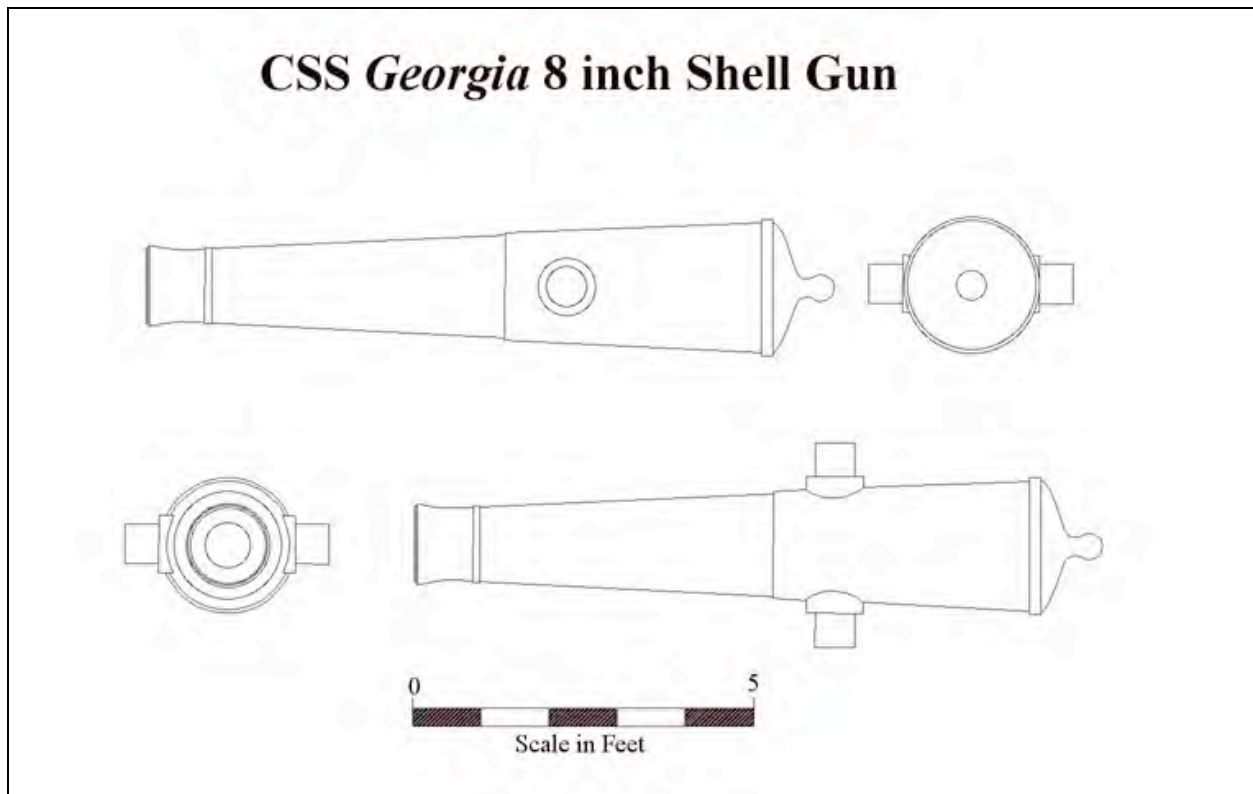
Cannon No. 2 was located on the channel side of the West Casemate with its muzzle pointed toward the channel and slightly downstream. The cascabel of Cannon No. 2 is located 62.9 feet from the West Casemate Datum. The cannon has a total length of 11-feet 3-inches and a maximum diameter of 2 feet (Figure 41). The cannon has no reinforcing bands and its flaring muzzle has a bore diameter of 8.5-inches (cleaned of concretion). Comparing the design and bore diameter of Cannon No. 2 with historical references and Civil War ordnance suggests that the piece is an 8.5-inch shell gun similar to a Sea-Coast type. Three VIII shell guns were listed for *Georgia*, but they were noted as removed in the 1860s. The two remaining unbanded guns on the wreck were IX inch shell Dahlgren Pattern (Swanson and Holcombe 2003:84-85). The shape of the piece does not correspond to a Dahlgren, especially with regard to the ring located above the cascabel.

Figure 41. AutoCAD line drawing of Cannon No. 2. The design and bore diameter suggests that the piece is an 8.5-inch shell gun similar to a Sea Coast type.

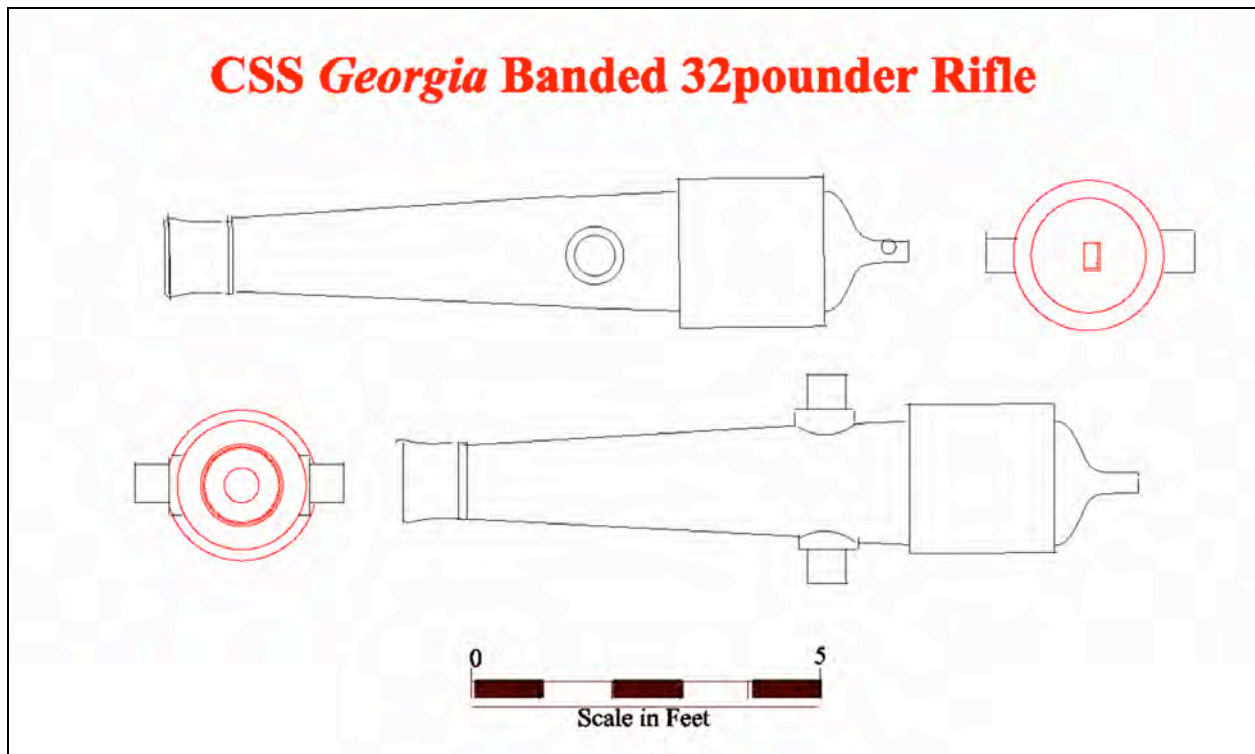
Although preliminary, the size, design, and caliber of this gun suggest that the piece is a 32-pounder Model 1846 that has been turned and banded. As stated, *Georgia* had six guns aboard at

Figure 42. AutoCAD line drawing of Cannon No. 3. Although preliminary, the size, design and caliber suggest that the piece is a 32-pounder Model 1846 that has been turned and banded.

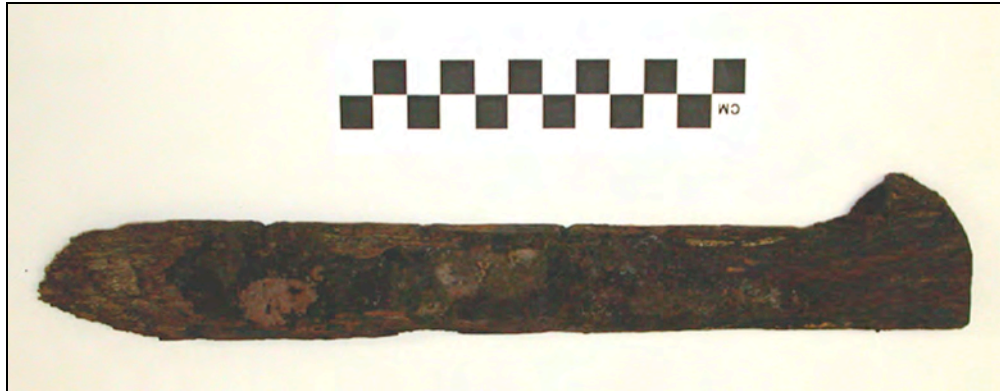
Several miscellaneous artifacts were observed during diving operations, brought to the surface, briefly recorded, and then re-deposited. These included a fragment of a scale balance and a fragment of a chain link. Presented in Figure 47, the balance or beam of a scale from which hung both the weights and the item being weighed, has “V” indentations along its upper edge marking calibrated locations for a corresponding weight (pounds?). The far-left indentation has the

number 80 impressed on the original surface, while the number “90” is visible beneath the far right V.

Figure 47. Photograph of balance fragment with an intact end at the right. Note the “V” indentations along the upper edge marking calibrated locations for a corresponding weight.

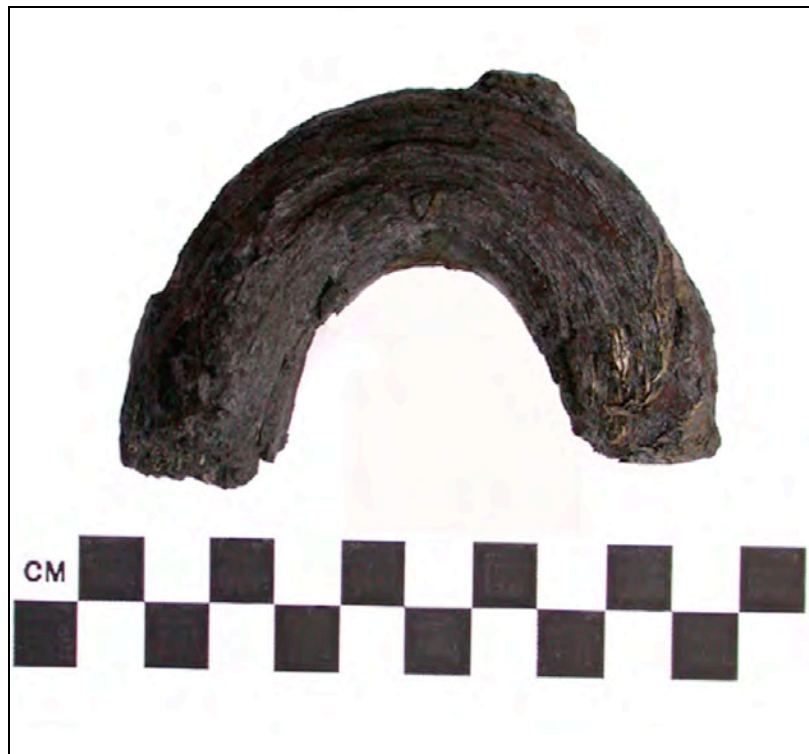
Also recovered was a small chain link fragment, ovoid in shape and 9.5 centimeters (3.75 in.) wide (Figure 48). Recovered adjacent to the small deteriorated section of casemate and hawse pipe south of the East Casemate, the chain link fragment was associated with other sections of deteriorated fragments of chain.

Figure 48. Photograph of chain link fragment recovered adjacent to the small, deteriorated section of casemate south of the East Casemate.

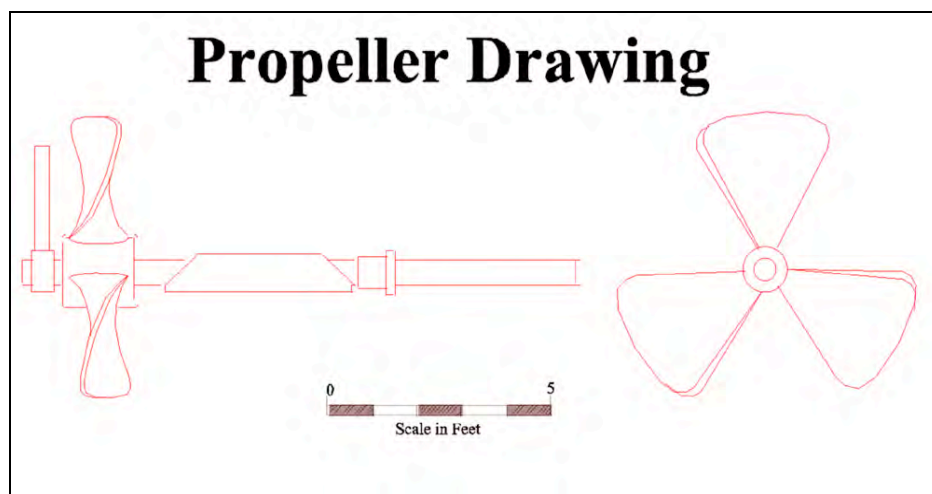
Figure 60. AutoCAD line drawing of propeller and shaft.

Historical sources indicate that CSS *Georgia* was powered by “a double engine and twin propellers” (Barnwell 1981:203, 206-208; Melton 2002:19). That description has been confirmed at the wreck site. The 2003 investigation of CSS *Georgia*’s remains identified a propeller and shaft, two steam cylinders, a condenser, and several pipe fittings (see Figure 27 above). The three-blade propeller measured 8 feet in diameter. It was mounted on a 6-inch diameter shaft approximately 12 feet 6 inches in length (Figure 60). The configuration of the Strut, cutlass bearing, and stuffing gland indicate that the propeller was mounded relatively close to the side of the hull and not in the sternpost.

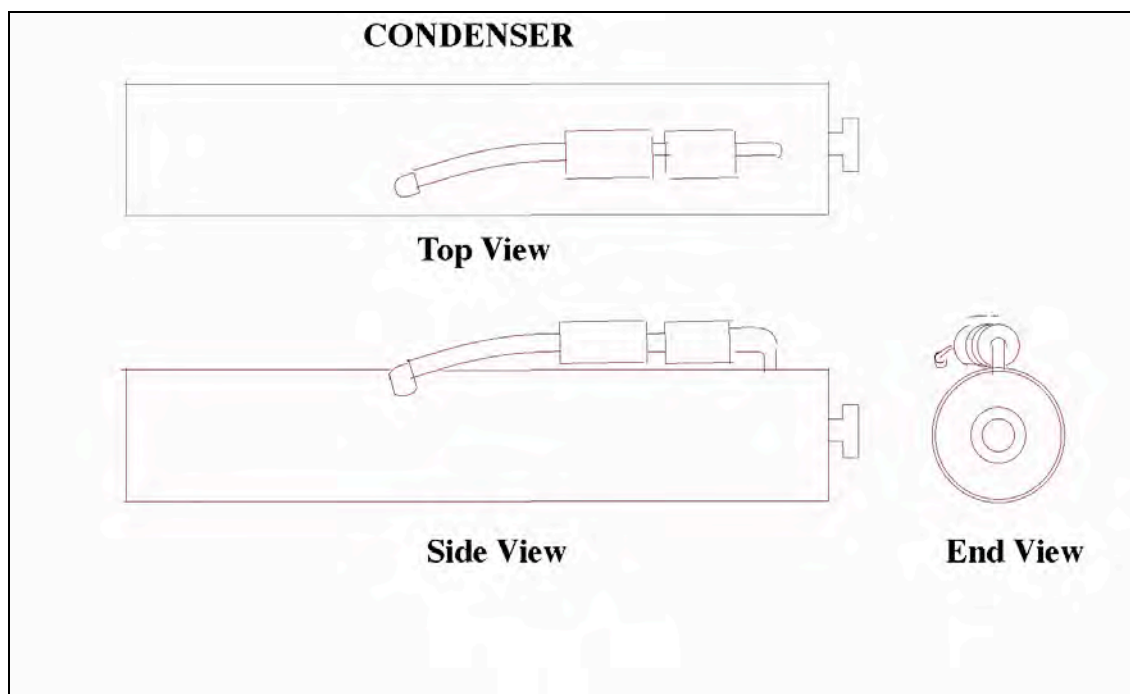
Figure 64. AutoCAD line drawing of condenser located on the site.

Because of the salt and sediment content of the Savannah River *Georgia* was fitted with one or more steam condensers (see Site Plan, Figure 27). What appears to be one of the condensers was found in the immediate vicinity of the 32-pounder smoothbore south of the largest section of casemate. The cylindrical condenser measured 9 feet 4 inches in length and is 20 inches in diameter (Figure 64). Cylindrical condensers were not uncommon during the period and most vessels operating in salt, brackish or high sediment environments would likely be fitted with a condenser. The length and diameter of the cylinder suggests that there was one condenser for each of *Georgia*'s steam cylinders.

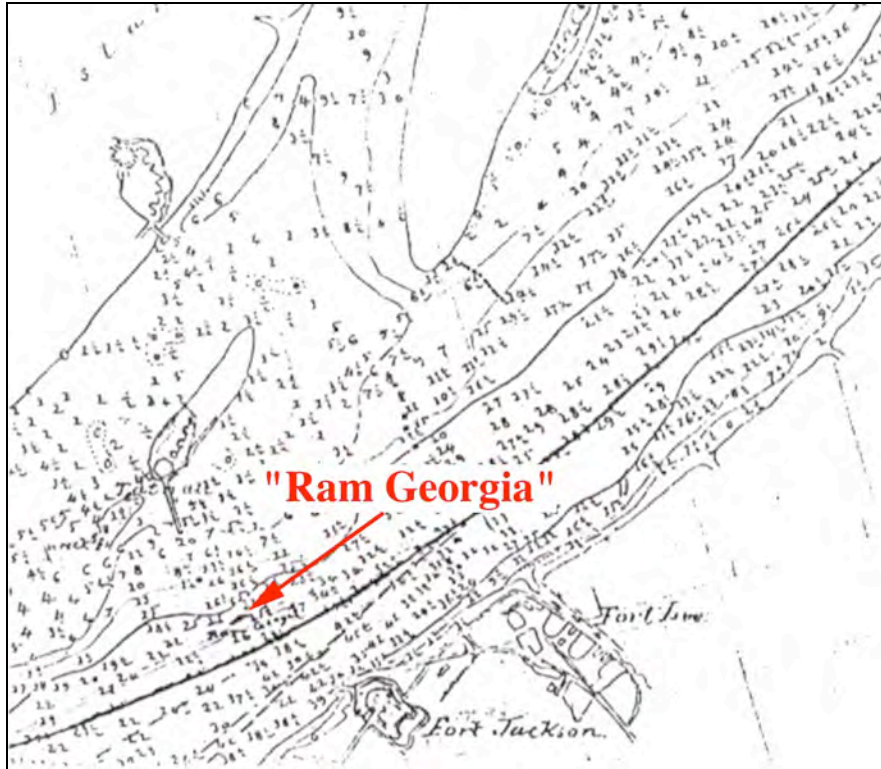
The 1872 report of the Chief of Engineers states the *Georgia* wreck “lies on the north side of the channel abreast of Ft. Jackson and has occasioned accident. It has now 11 feet over it at low water, with a sand-bar forming around it on the north side and west end” (Garrison et al. 1980:35). Figure 84 illustrates a section of an 1867 survey map produced immediately after the war. Shown opposite Fort Jackson, the “Ram Georgia” is located in 21 to 26 feet of water with little if any shoaling noted. However, Figure 85, the survey map that mirrors the 1872 report, shows dramatic shoaling immediately adjacent and north of the wreck, as well as an increase in the main channel depth to the south. Shoal depths to the north are 10 feet versus the 21 feet five years earlier.

Figure 84. Excerpt from 1867 U.S. Coast Survey map of the Savannah River showing wreck of the “Ram Georgia” opposite Fort Jackson (as presented in Duff and Simmons 1995:2-35).

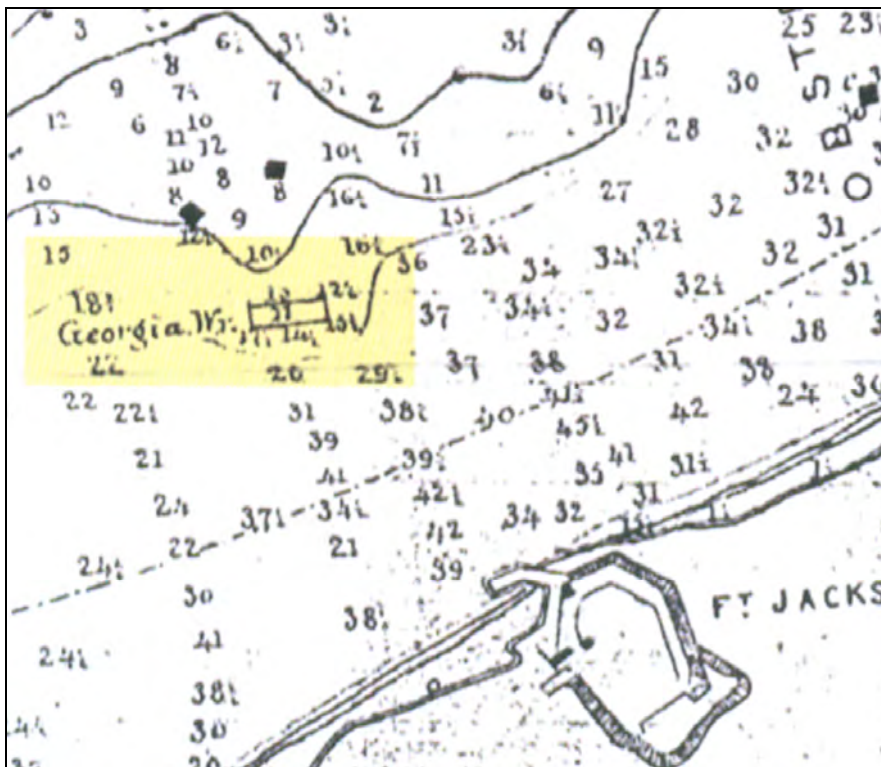
Figure 85. Excerpt from the 1871 Gillmore and Ludlow Map showing the shoaling on the north side of the wreck site (as presented in Swanson and Holcombe 2003:96).
