IN SITU ARCHAEOLOGICAL EVALUATION OF THE CSS *GEORGIA* SAVANNAH HARBOR, GEORGIA

Final Report

February 2007

**Contract No. DACW21-98-D-0019
Delivery Order No. 0059
Navy Archaeological Research Permit No. PCI-2003-002**

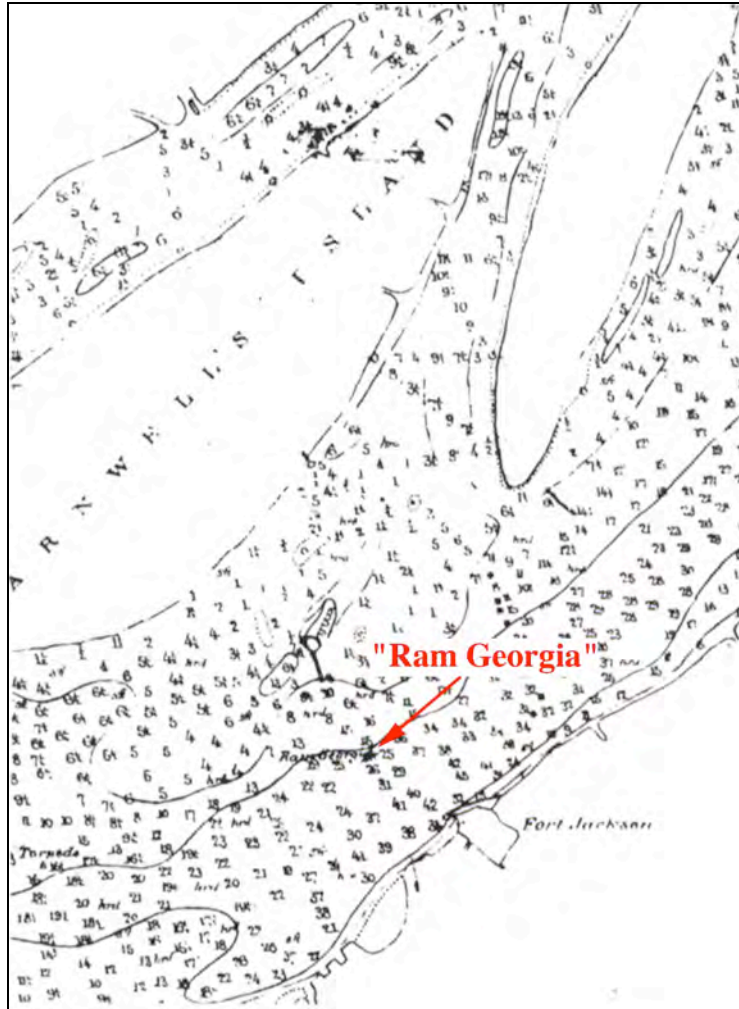
Dated one year after the Gillmore and Ludlow map, the 1872 U.S. Coast Survey map shown in Figure 86 mirrors the earlier map depicting shoaling around the wreck. However, the shoaling does not appear as pronounced, differing some five feet deeper on the north side of the wreck while the main channel depths correspond. After this date, the wreck site disappears from historic maps, possibly as a result of its “clearance” by Wells, or because the focus turned to the control of the main channel, the wreck lying outside the channel to the north as it does today. Whatever the case, perhaps the greatest known effects on the wreck site can be attributed to the results of these continued efforts at channel improvements, improvements that continue to this day. The current archaeological work on the *Georgia* wreck site, a component of a channel enlargement feasibility study, illustrates this fact.

Figure 86. Excerpt from 1872 U.S. Coast Survey map of the Savannah River (as presented in Duff and Simmons 1995:2-36).

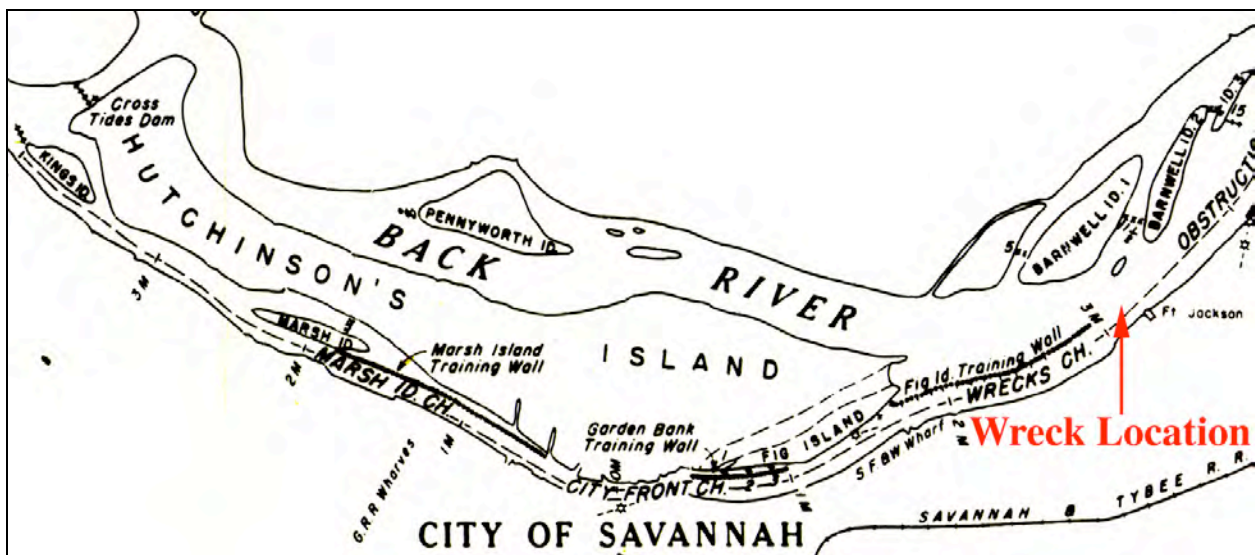
Capt. O.M. Carter produced a map in 1891 to accompany the Annual Report for the Corps of Engineers. While little specific wreck information is presented, including an absence of any indication of the *Georgia* wreck site, the map is the first to show both Hutchinson and Fig Island as one land mass. Furthermore, it illustrates the funneling of the tide through the main channel by the construction of numerous features including the Cross Tides Dam (1937) at the north of Hutchinson Island and the Fig Island Training Wall at the southern end of the Fig Island, just to the west of the wreck site (Figure 87).

Figure 87. Excerpt from 1891 survey map of the Savannah River by Capt. O.M. Carter (as presented in Granger 1968).

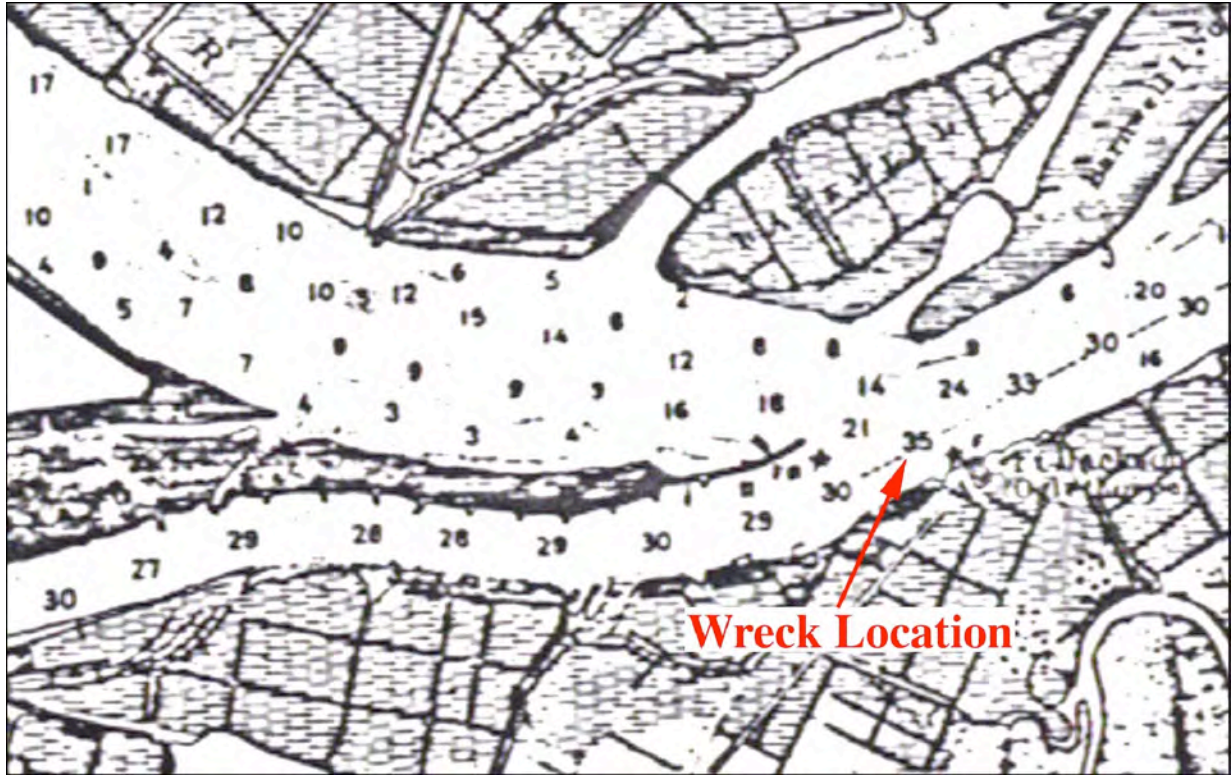
Little channel morphology change is noted on maps up to and through the turn of the century for the area surrounding the *Georgia* wreck site. However, as illustrated in Figure 88, by the first quarter of the 1900s, through the use of dikes and or dams, Barnwell Island No. 1 and Island No. 2, located just to the north of the wreck site, are starting to merge into one land mass. With the addition of dredge material in-filling, by the 1940s the islands have completed their transformation and comprise the solid northern or South Carolina bank of the river. Illustrated in Figure 89, a 1940 map represents the general topography of the area as it exists today.

Figure 88. Excerpt from 1923 U.S. Coast and Geodetic Survey map of the Savannah River (as presented in Watts 1992:68).

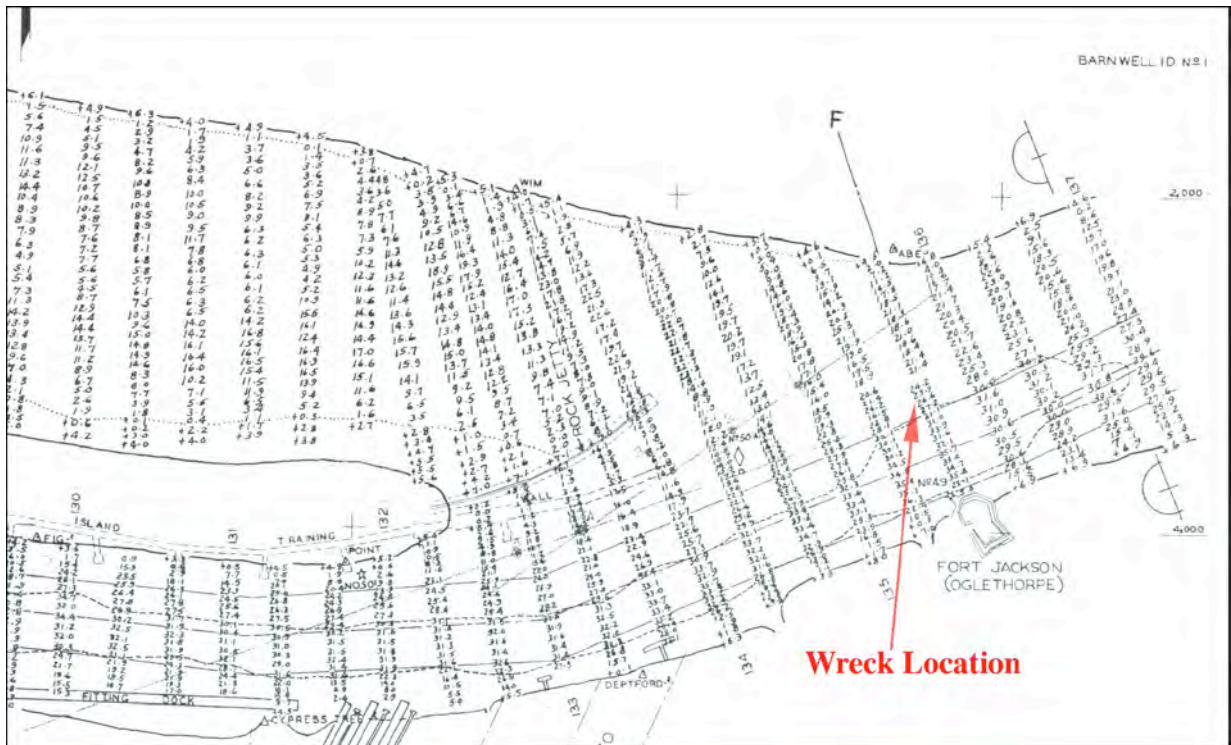
Figure 89. Excerpt from 1942 U.S. Army Corps of Engineers, Savannah District Annual Survey - 1942, Savannah Harbor, Georgia showing Barnwell Island now a complete landmass with South Carolina.

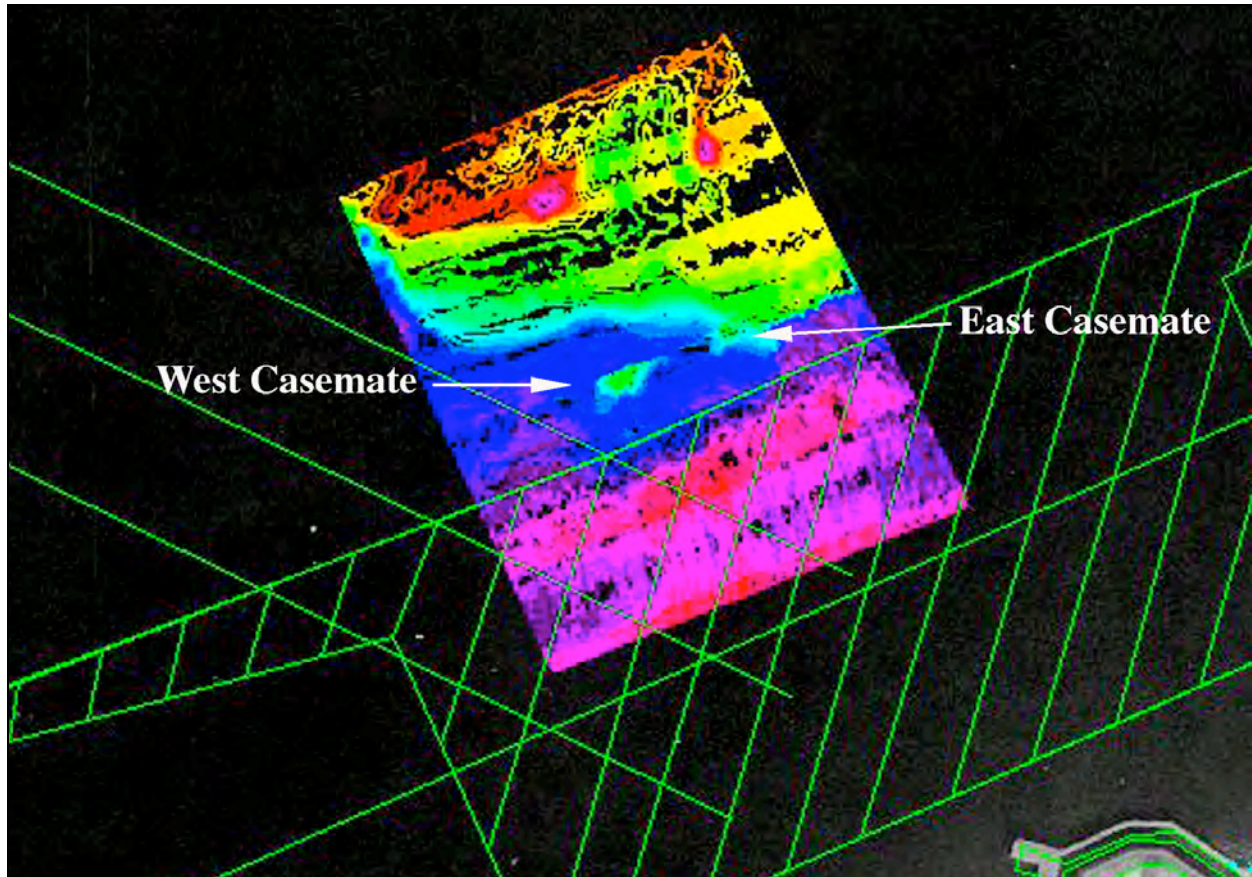
Bathymetric maps and images were also analyzed in an effort to characterize the site and identify any changes over time such as sediment buildup or loss. Figure 90 is a 2002 Reson Bathymetric image of the site that graphically illustrates the site and its surrounding environment. The dark pinks indicate the deepest portion of the dredged channel, with actual linear dredge marks visible. The West Casemate appears as an isolated green pedestal surrounded by slightly deeper blue, indicating a surrounding uniform depth. The greens and yellows indicate shallower water as you go north toward the South Carolina bank.

Figure 90. 2002 Reson Bathymetric image of the site that graphically illustrates the site and its surrounding environment (Courtesy of the U.S. Army Corps of Engineers, Savannah District).

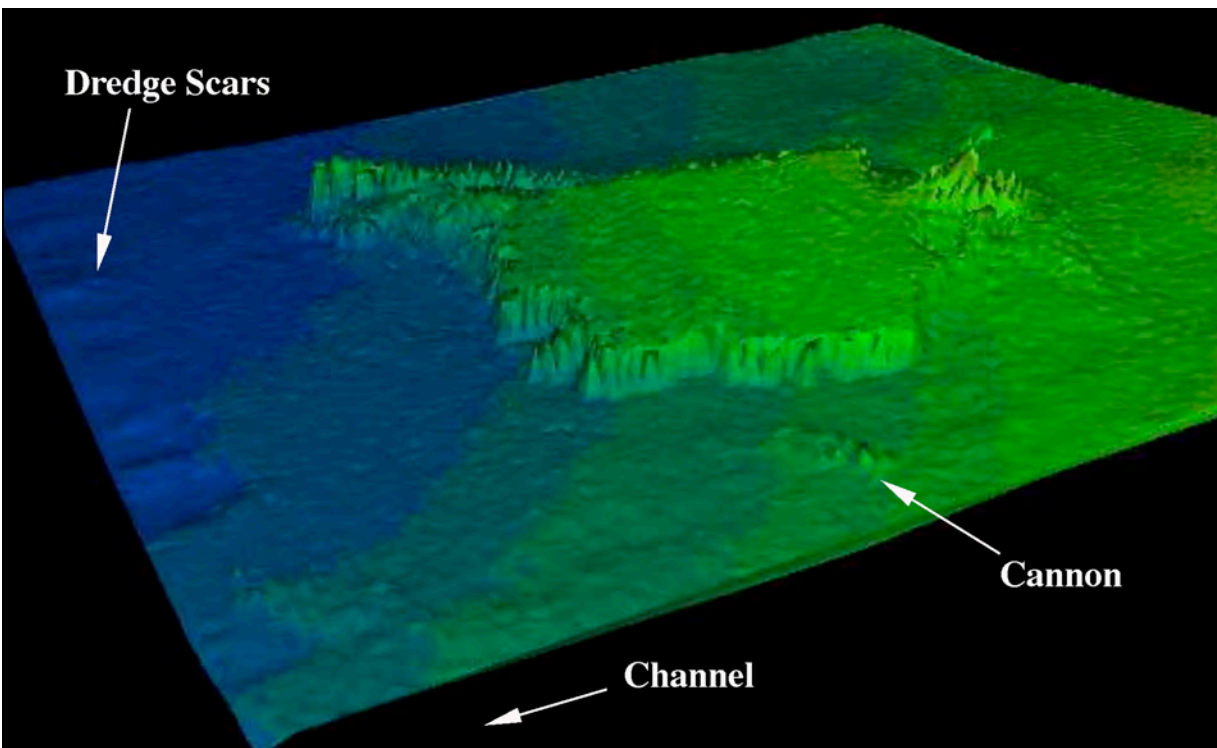
Figure 91, a 2003 Reson Bathymetric oblique image of the site taken just before diving investigations, illustrates the West Casemate similarly pedestaled on a uniform surrounding bottom. Like the 2002 image, depths can be seen to increase as one moves down slope from the East Casemate towards the West Casemate and into the channel proper. This is graphically illustrated in Figure 92 below, a close up image of the East Casemate. Because of our field

Figure 92. 2003 Reson Bathymetric image of the East Casemate section showing slope of site bottom and proximity of dredge cuts (Courtesy of the U.S. Army Corps of Engineers, Savannah District).

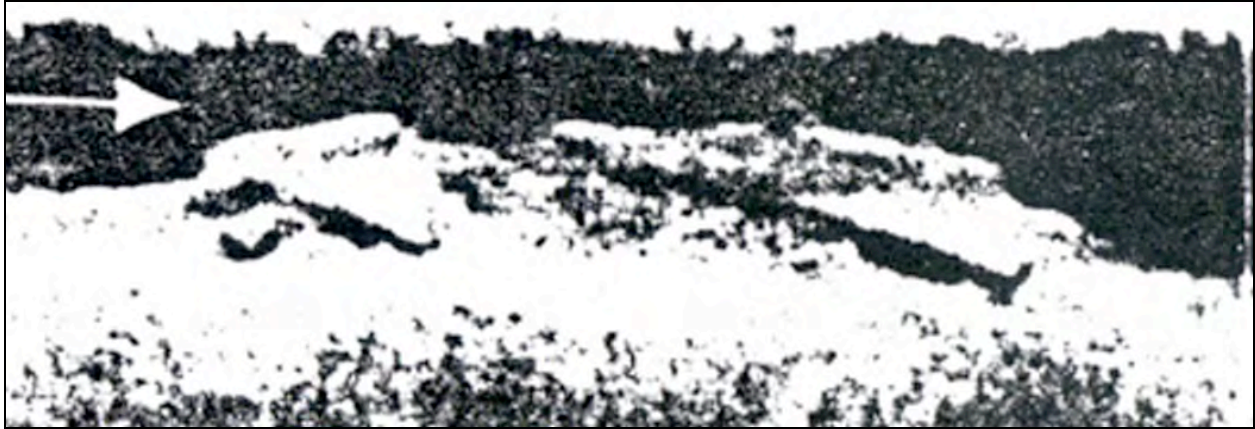
investigations we can state that there is little if any sediment surrounding the West Casemate, and little if any around the East Casemate, and both wreck sections rest on a hard bottom of miocene clay. Furthermore, when both the 2002 and 2003 images are contrasted with the 1979 sidescan image below, the wreck sections do not appear to be buried, suggesting little if any sediment was present at the site at this early, pre-Tide Gate Closure date (Figure 93).

Figure 93. Excerpt from the 1979 acoustic image showing casemate sections with little if any surrounding sediment (as presented in Garrison et al. 1980:Figure 39).

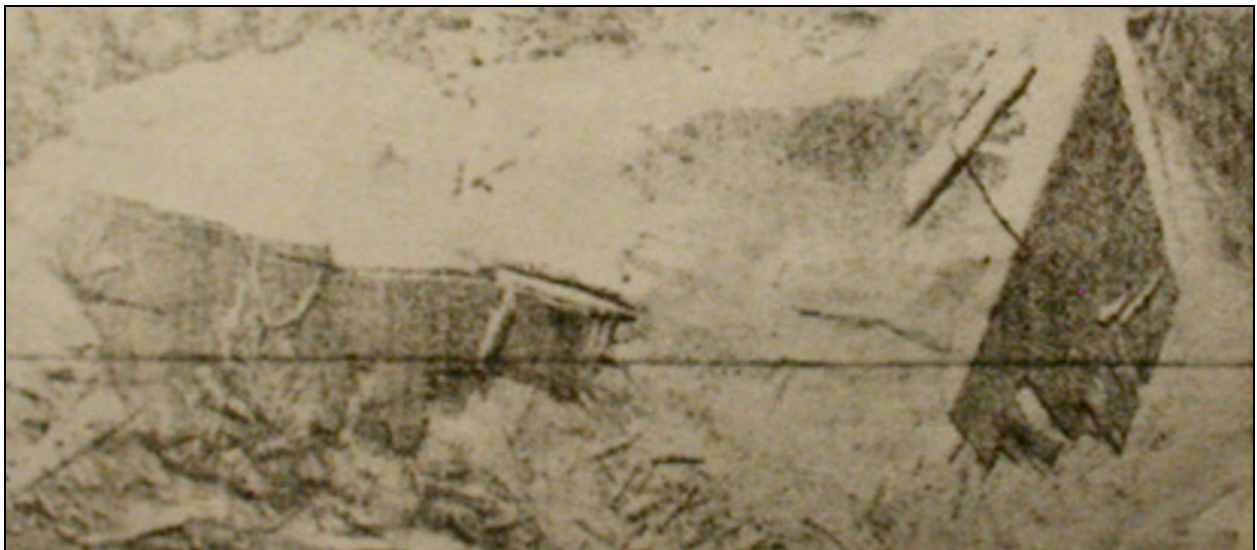
Figure 97. 1986 acoustic image of the wreck site depicting West (left) and East (right) Casemate sections (Courtesy of the U.S. Army Corps of Engineers, Savannah District).

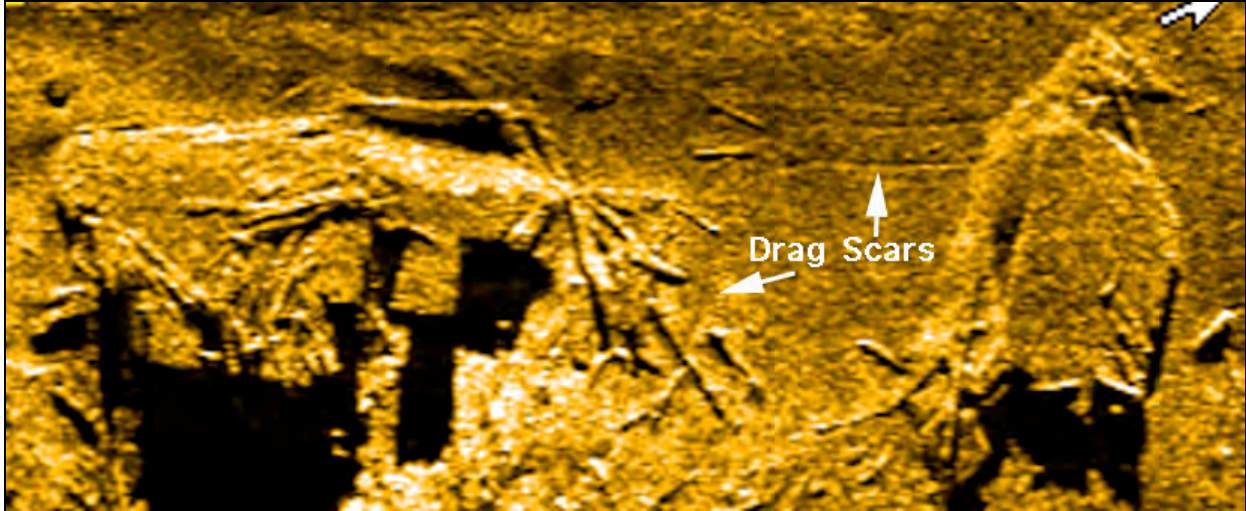
A comparative analysis of sidescan images from the 1986 study and the current 2003 study, a period of 17 years, shows virtually the same site composition and reveals, in some instances, severe degradation to the resource. Taking into account technological advances and directional movement in the survey vessel or tow fish, both the 1986 image (Figure 97) and the 2003 image (Figure 98) depict the West and East Casemate sections with only slight differences. Figures 99, 100, 101 and 102 are close-ups from both the 1986 and 2003 images showing comparative differences or changes to each casemate section highlighted in red. The changes in the 2003 images are all thought to be a direct result of the 1982 incident during which a vessel fouled the site’s wreck buoy dragging it and its 10-ton anchor through the site. Evidenced by two parallel lines visible in the Miocene clay bottom, what are believed to represent the anchor’s drag scars can clearly be seen in the 2003 image running between the casemate sections (Figure 98).

Figure 98. 2003 acoustic image of the West (left) and East (right) Casemate sections. Note the two linear drag scars at the top left of the East Casemate projecting toward the West Casemate, and a second fainter set running toward the channel to the right of the West Casemate. Also note 6 pdr cannon to the right of the East Casemate's midsection.
